Godre'r Graig Primary School, Godre'r Graig Preliminary Landslide Hazard and Risk Assessment Report Reference: ESP.7234e.3221

Godre'r Graig Primary School Preliminary Landslide Hazard and Risk Assessment

Prepared for: Neath Port Talbot County Borough Council

Report Reference: ESP.7234e.3221

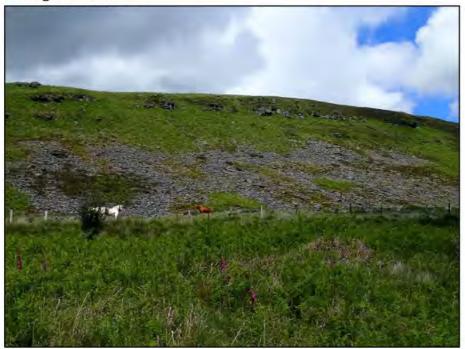
Plate 2: Rock outcrop (Rhondda Sandstone) with the associated talus slope below.

Larger individual blocks (rock falls) are present extending further downslope from the talus drape, the largest of which is 0.2m x 3.0m x 2.0m. A number of the features initially identified as rock blocks from the API actually comprise soil mounds (Plate 3). It is considered that the generation of large rock falls was probably associated with periglacial conditions at the end of the last ice age (approx. 11, 700 years BP) and consequently the main trigger for rock fall processes is no longer active. Smaller falls of cobble size blocks may still occur although again this process would have predominantly been active during periglacial conditions.

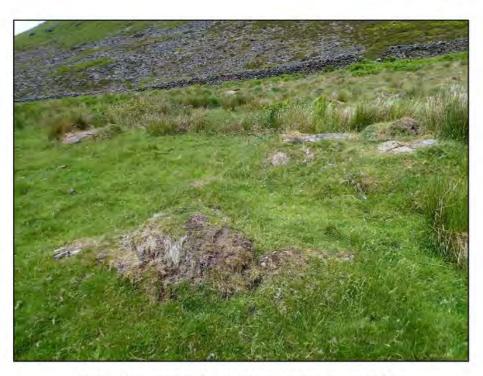
Plate 3: Soil mounds and rock blocks below the talus slope

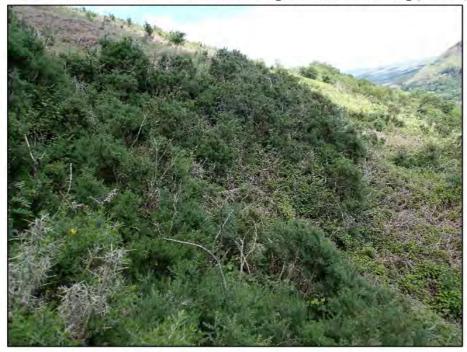
The base of this steeper terrain is marked by a district concave break in slope which corresponds to the outcrop of the No2 Rhondda coal seam at the base of the Rhondda Sandstone. Coal workings are evident in the form of adits and associated spoil in the NE of the study area, with the working of the seam apparently evident in the 1973 and 1975 aerial photographs. Below the No 2 Rhondda the Llynfi Beds are present, comprising alternating sandstone and mudstone resulting in stepped topography. The published geological map shows the Upper Pinchin Coal seam as outcropping at approximately 178mOD. This is associated with over steep, anthropogenically modified, terrain as well as a series of adits reflecting its historical working (Plate 4).

Plate 4: Anthropogenically modified over steep slope and location of a formed adit

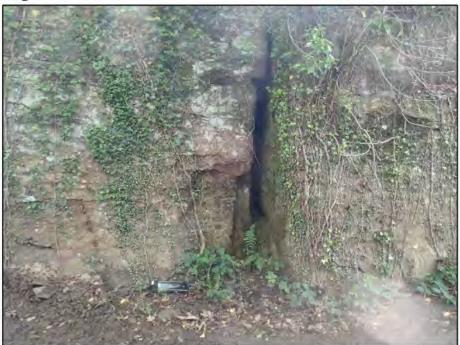
Two abandoned quarries are also present located above the outcrop of the Upper Pinchin. These are shown on the earliest historical maps (1877). Both quarries are associated with spoil heap with extend down slope. The Llynfi Beds are exposed at the Quarry to the NW of the School comprising weak to medium strong, thinly bedded, dark grey, partially weathered to unweathered, micaceous sandstone. Bedding dips at 20/185. Two additional discontinuity sets were observed 84/274 with an approximately 1m spacing and 74/018 with a spacing of approximately 5m. The latter set is dilated with an aperture of up to 10cm (Plate 5), reflecting either the effects of mining or cambering.

Plate 5: Bedding dipping from left to right (20/185) the rock face is formed by joint set 84/274 and the dilated joint set is formed by 74/018.

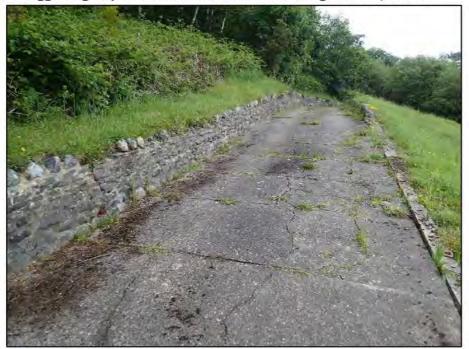
road (Plate 8) and a shallow depression, was noted within the cemetery at approximately the same level. At the rear of the School there was no evidence of landslides or distress. However, terracettes suggesting very shallow soil movement and wet ground is present.

Plate 8: Distress evident in the upper part of the cemetery.

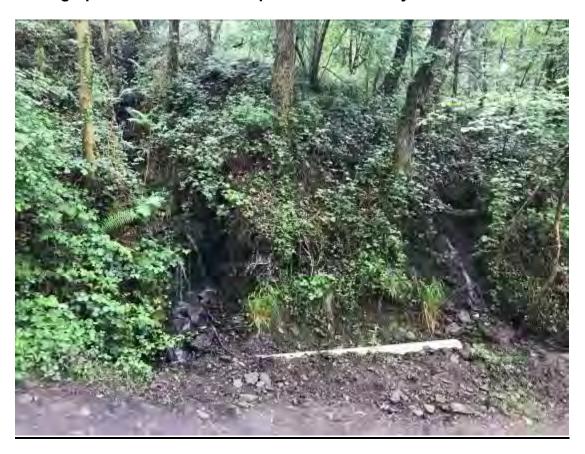
Photograph 3 – Flows from adit positions to Pentwyn Farm access track

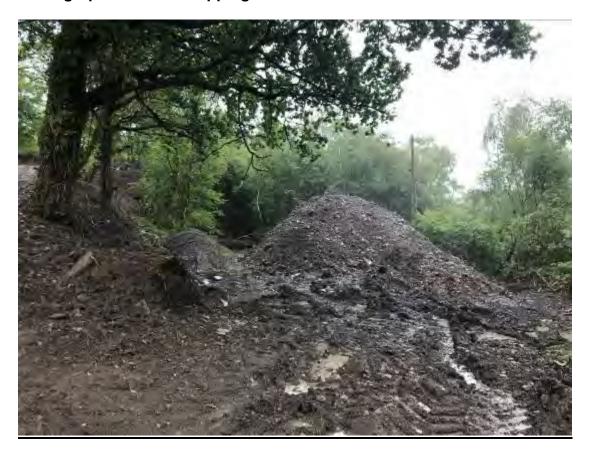
Photograph 4 – Recent tipping of material at Site 1

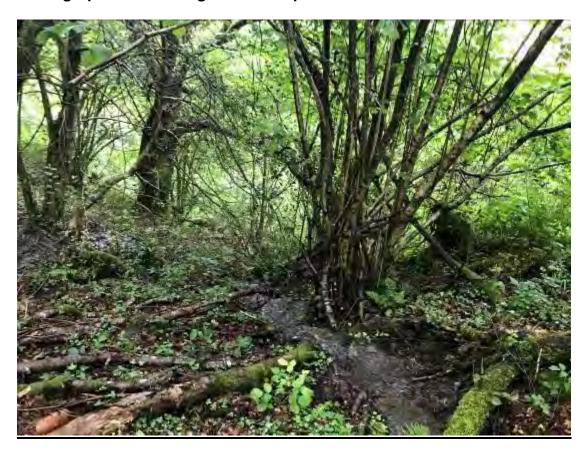
Photograph 7 – Discharge from adit positions at Site 1

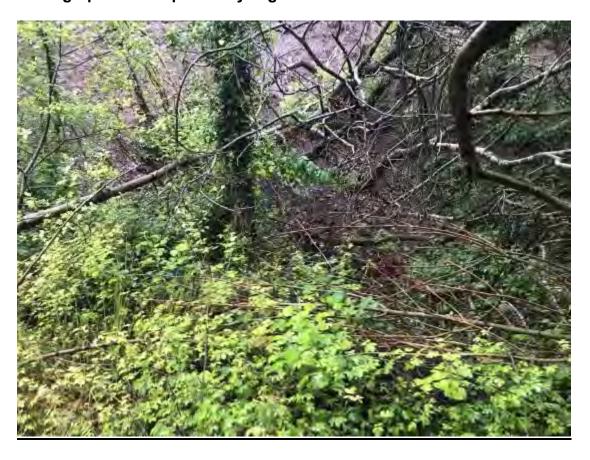
Photograph 8 – Steep densely vegetated flanks of Site 1

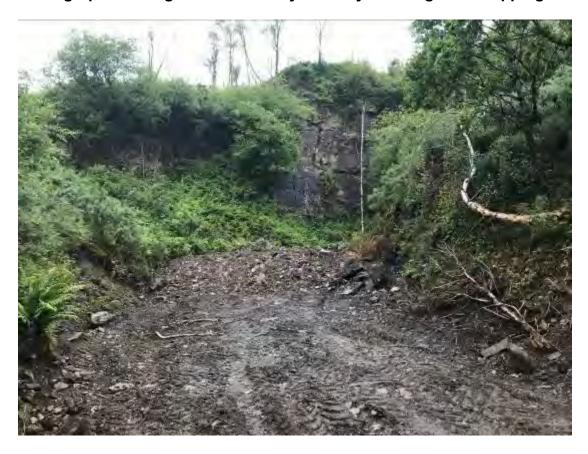
Photograph 11 – High wall of Pentwyn Quarry showing recent tipping

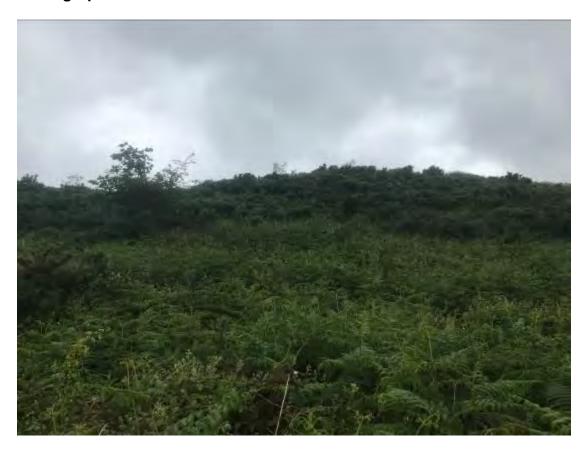
Photograph 28 – View of Site 3 showing collapsed adit positions

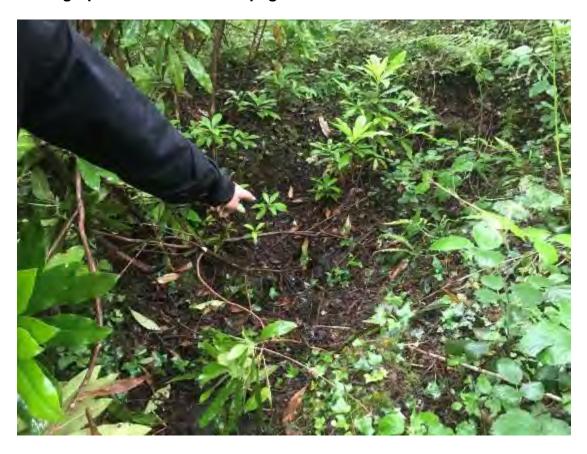
A moderate seepage was noted from a former adit near to the quarry which was observed to pass into what was described as coarse quarry spoil and re-emerge down slope where it eventually flowed into a drain at the rear of Godre'r Graig School.

Photograph 29 – Moderate seepage at SW section of Site 2

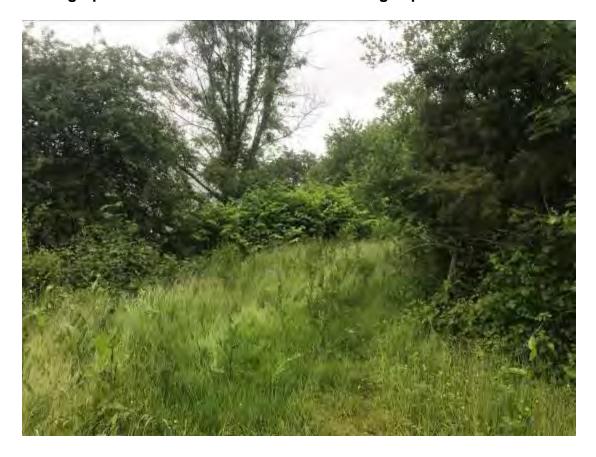
Photograph 32 – Field to rear of school showing Japanese Knotweed

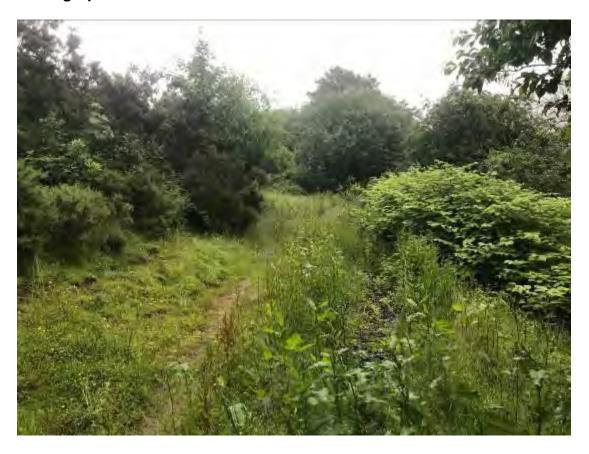
Photograph 33 – Stone filled cut off drain to rear of school
