**PROJECT: CILMAENGWYN LANDSLIDE
ASSESSMENT OF HAZARDS AND RISKS**

PLATES

EARTH SCIENCE PARTNERSHIP

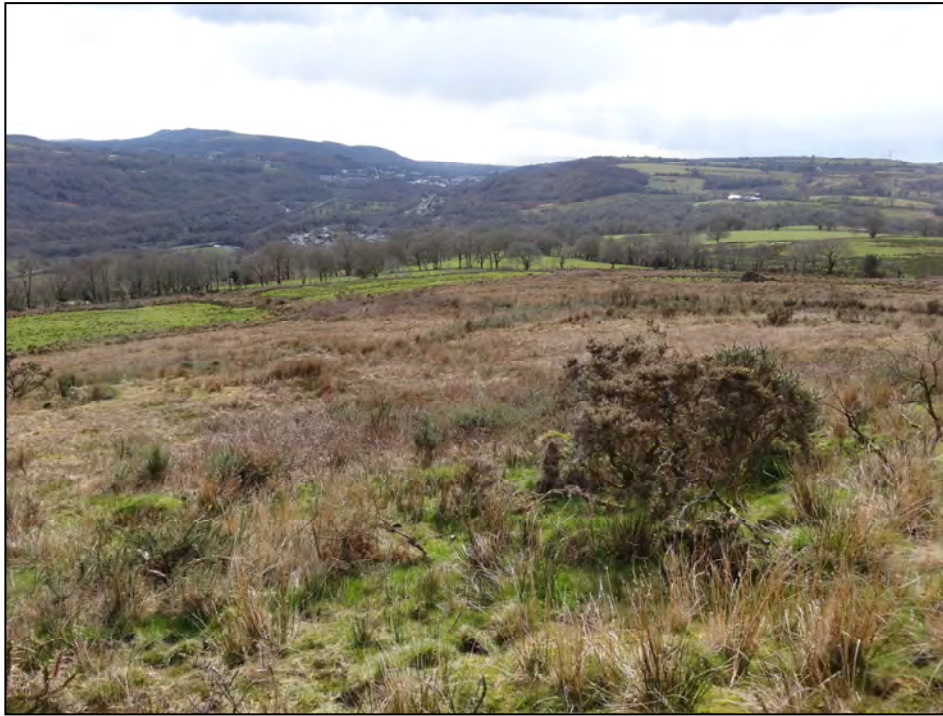
Plate 1: General view of landslide and area to the south, taken from eastern area looking southwest.

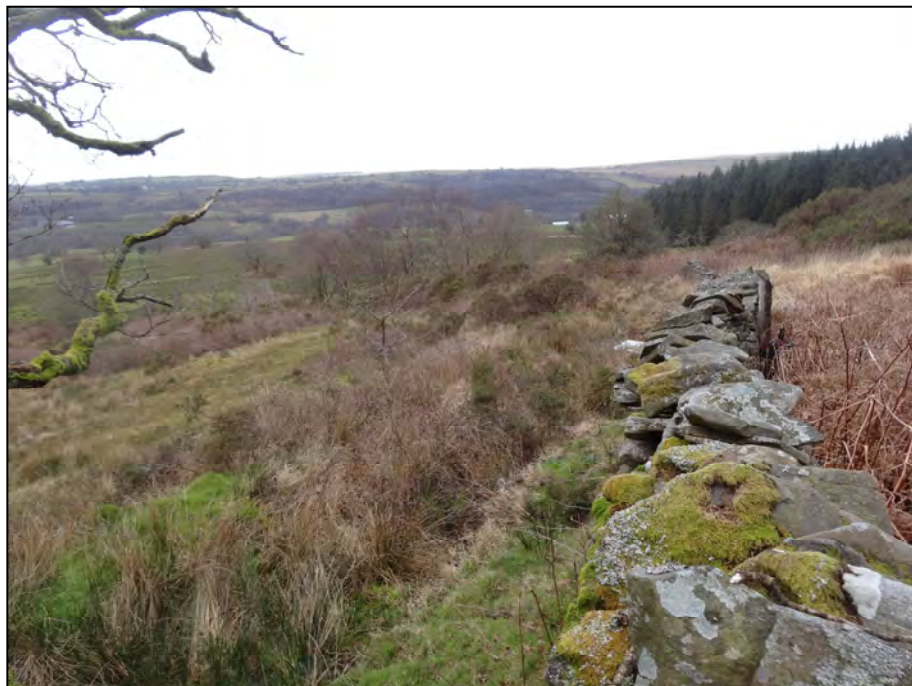
Plate 2: General view western area of the landslide, looking west along dry stone wall.

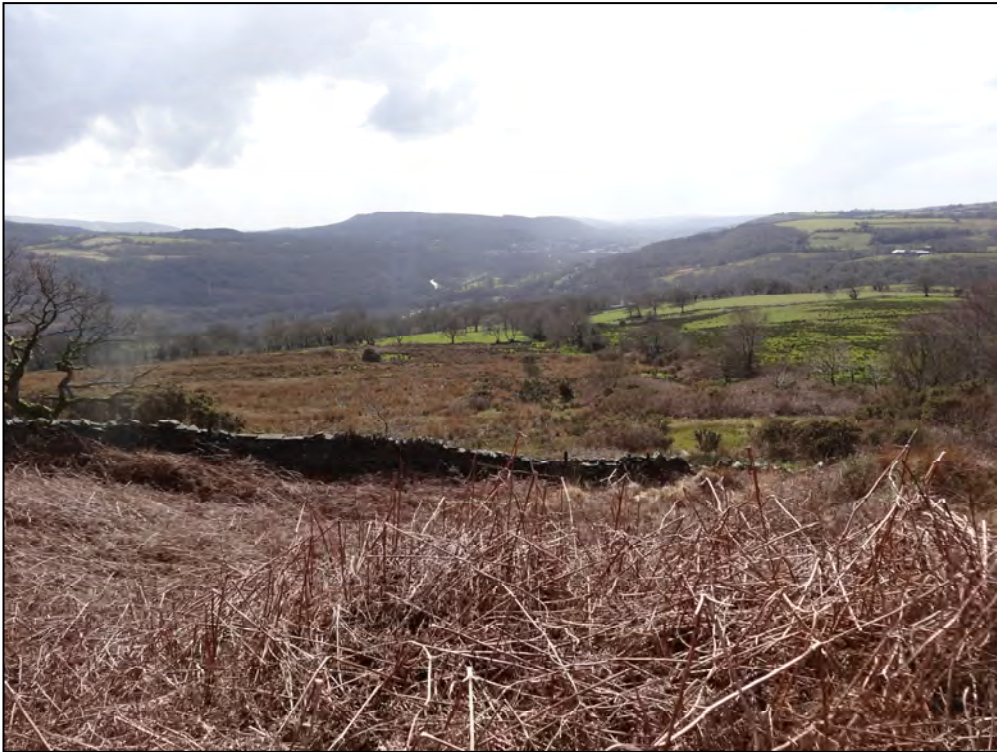
Plate 3: View of western portion of landslide, taken looking south with spoil heap of mine adit no 2 in foreground.

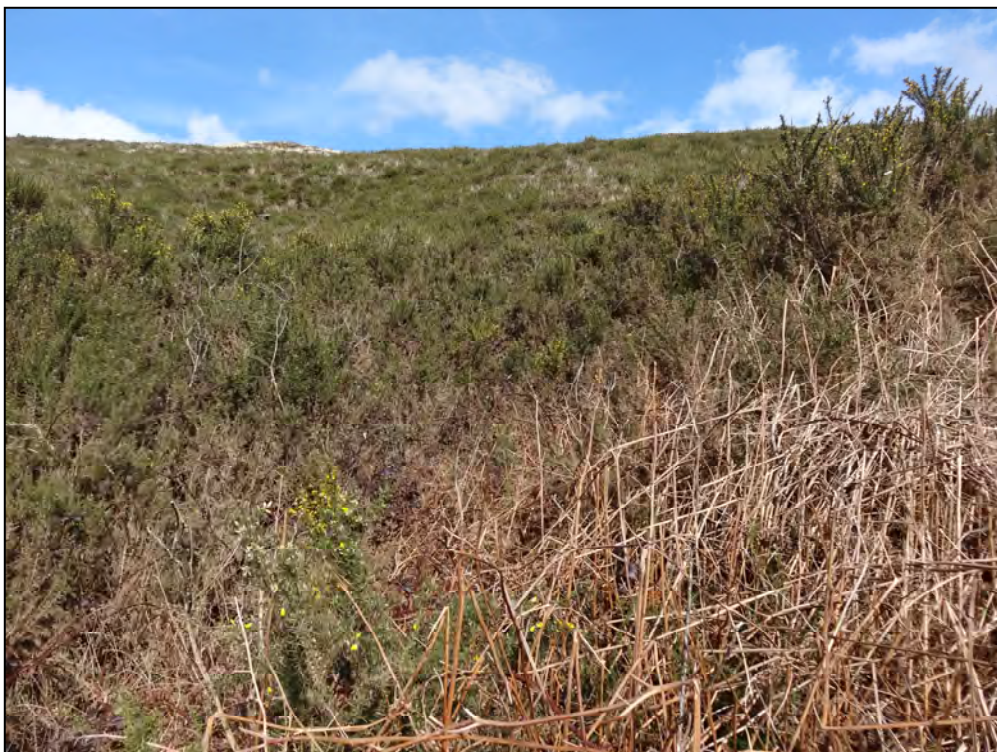
Plate 4: View Quarry (M1) (overgrown) in the background and Adit (M2) in foreground, looking north.

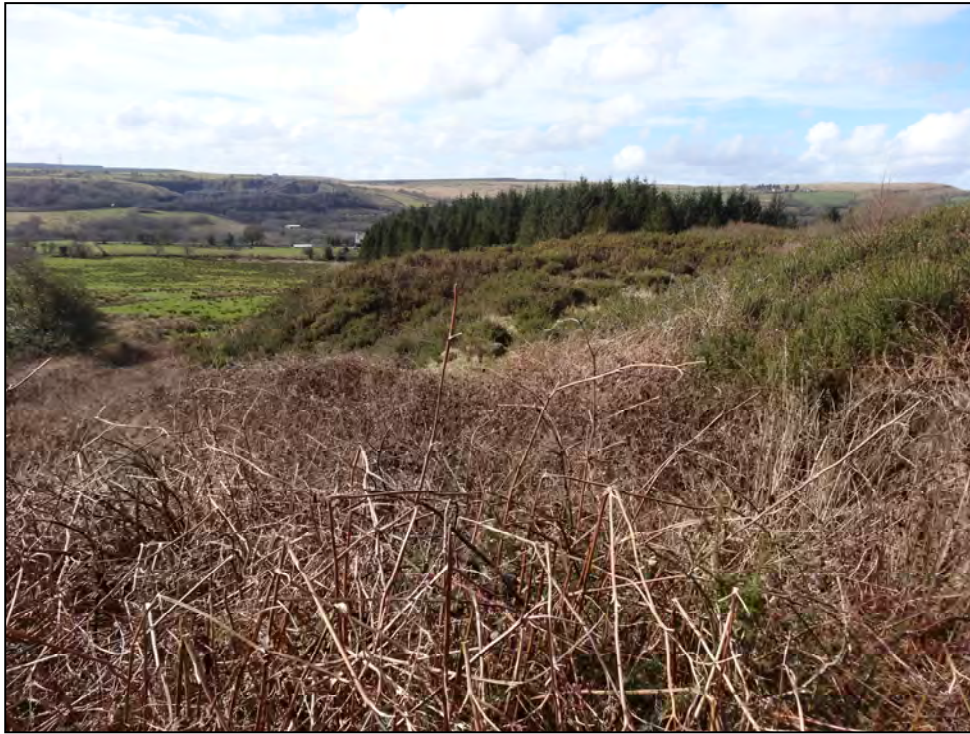
Plate 5: View of adit (M2) in foreground and spoil mound (M6) in middle ground, looking west.

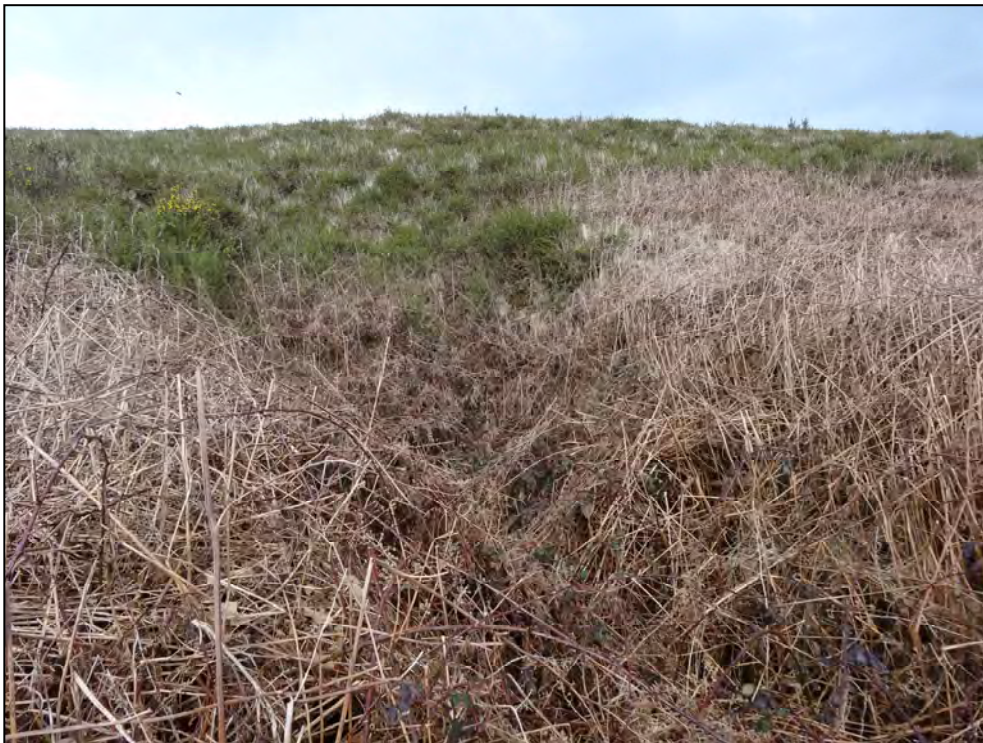
Plate 6: View of adit (M3) looking north.

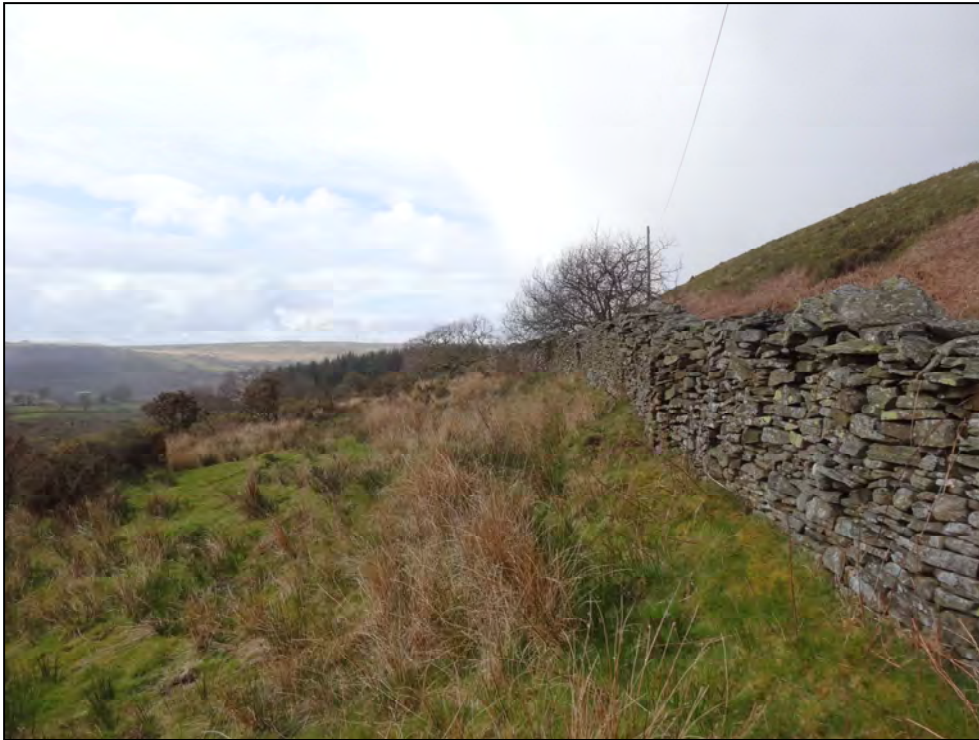
Plate 7: View along rear of landslide, note adit (M3) in the right of the photo. Note no drainage ditch. Photo taken looking west.

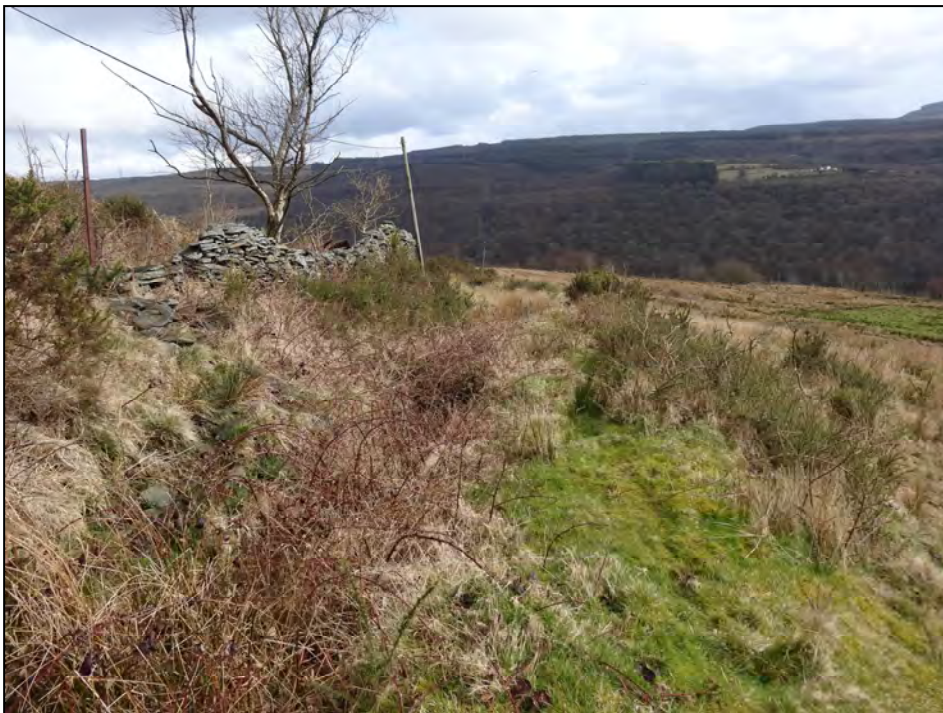
Plate 8: View along rear of landslide looking east. Note disturbed telegraph pole in middle distance and ditch in foreground.

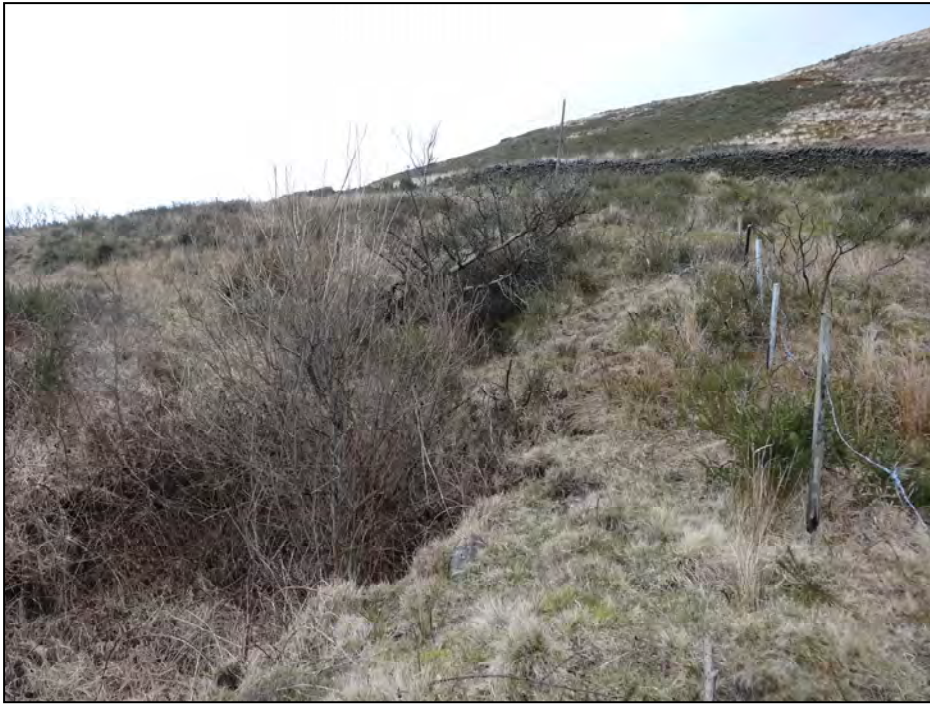
Plate 9: Stream (S1) in the east of the site, looking north. Note fallen tree leaning telegraph pole in background.

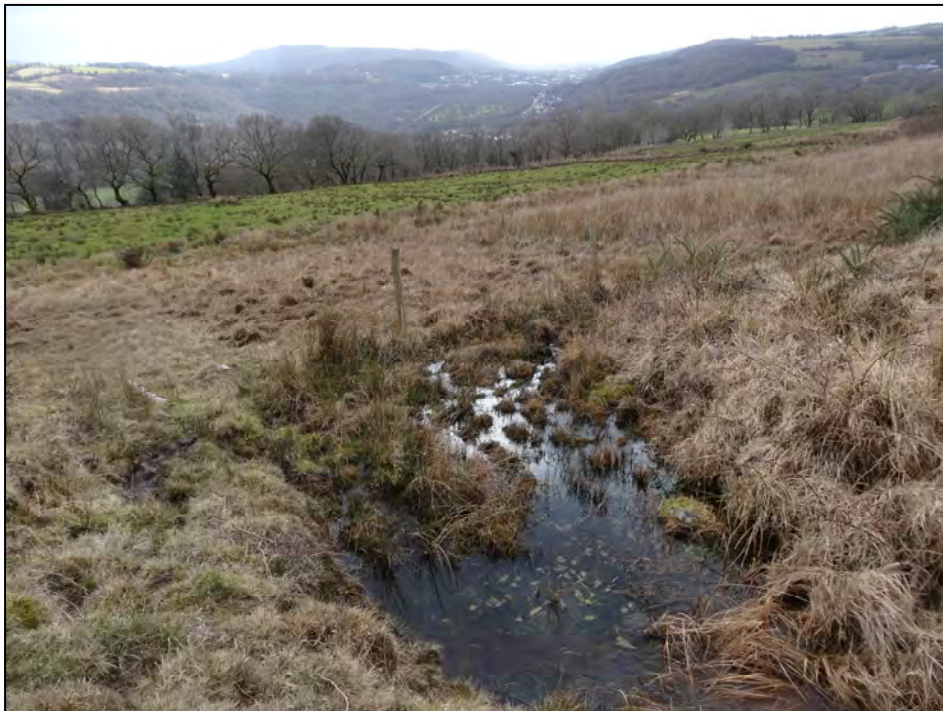
Plate 10: Photo looking south from same point as Plate 9 above. Stream (S1) Standing water and water-logged ground beyond.

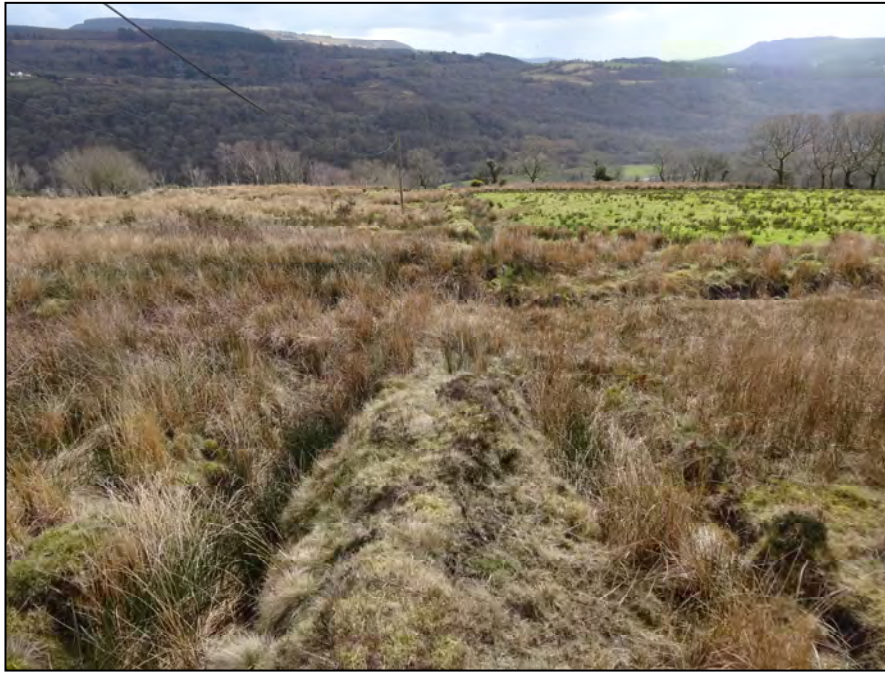
Plate 11: Photograph showing man made 'bund' in the east, looking toward the south.

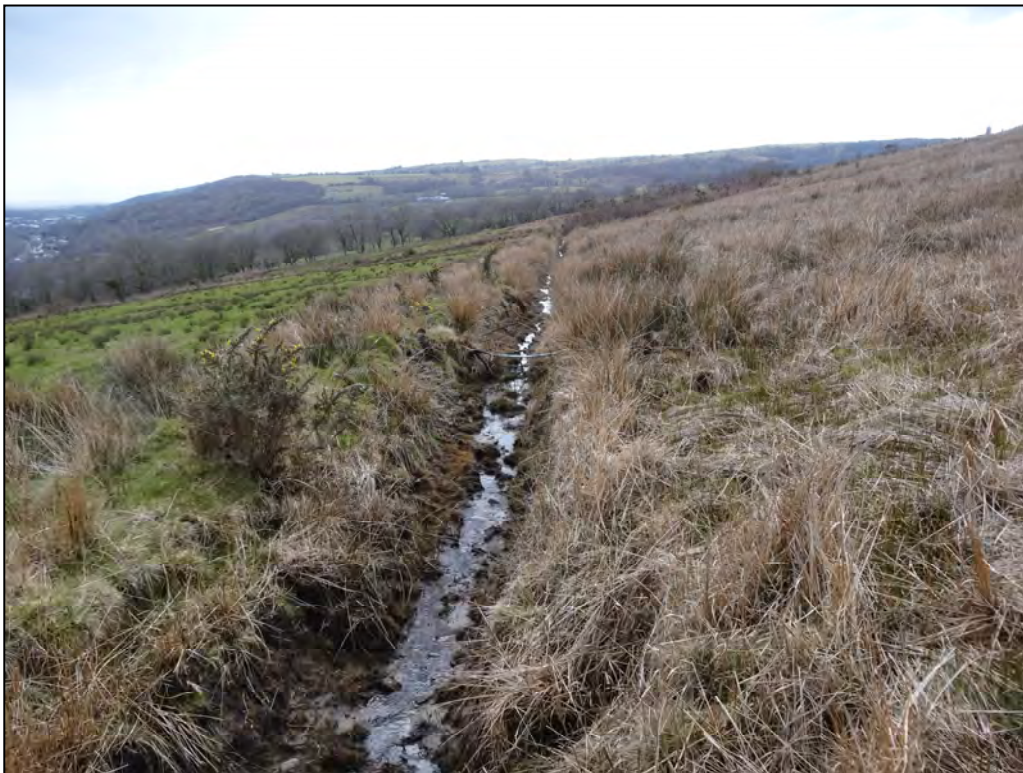
Plate 12: Photograph of ditch running along the southern margins of the landslide, looking west. Note difference in grass either side of ditch.

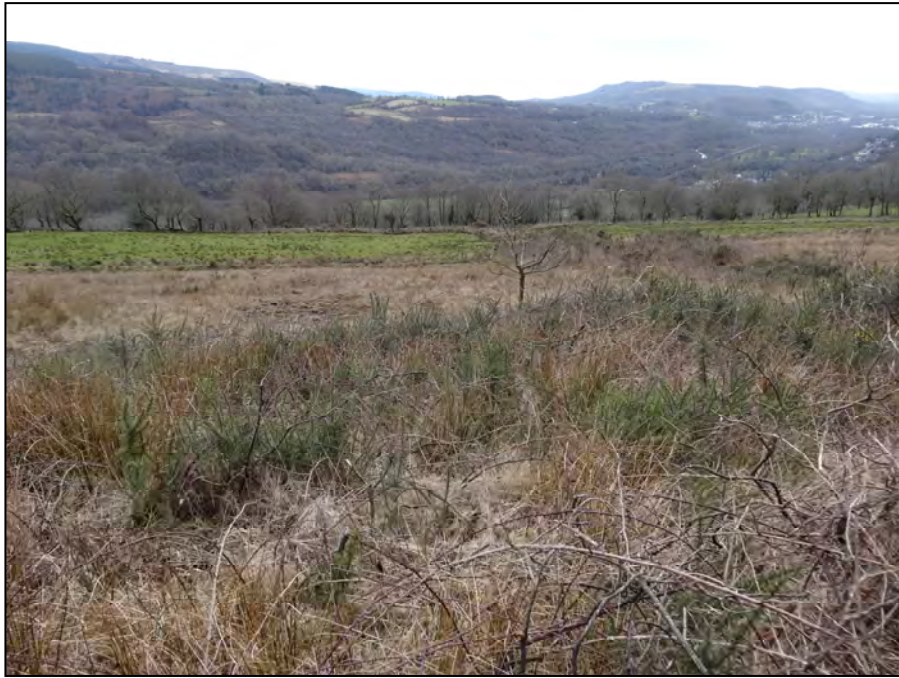
Plate 13: Photo taken near the centre of the landslide area looking south. Main 'lobe' delineated by darker tones ground in foreground, covered with gorse. Ditch shown in Plate 12 seen in middle distance of photo.

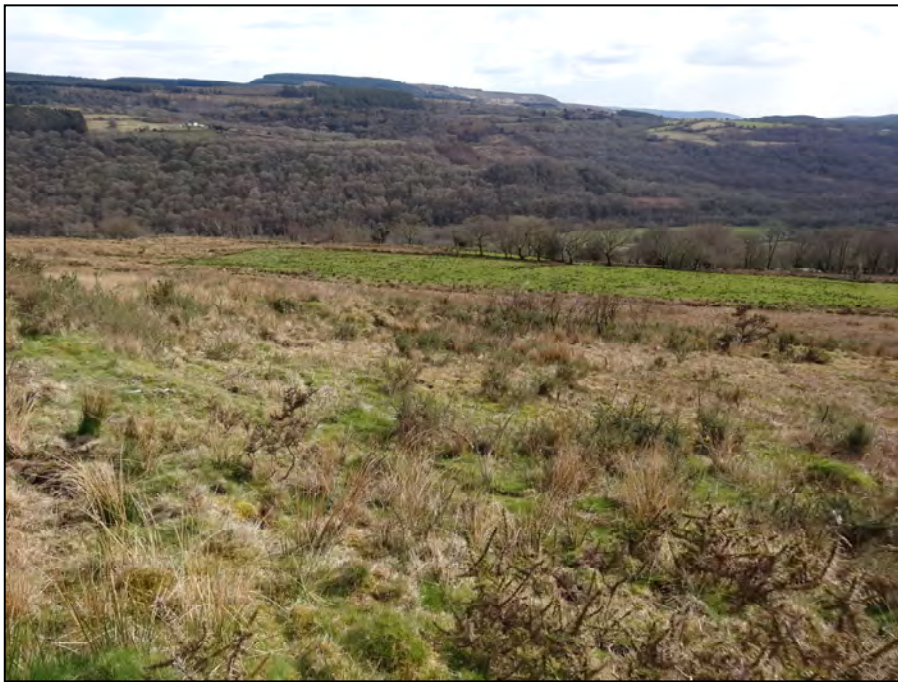
Plate 14: View of central eastern portion of the site, looking southeast.

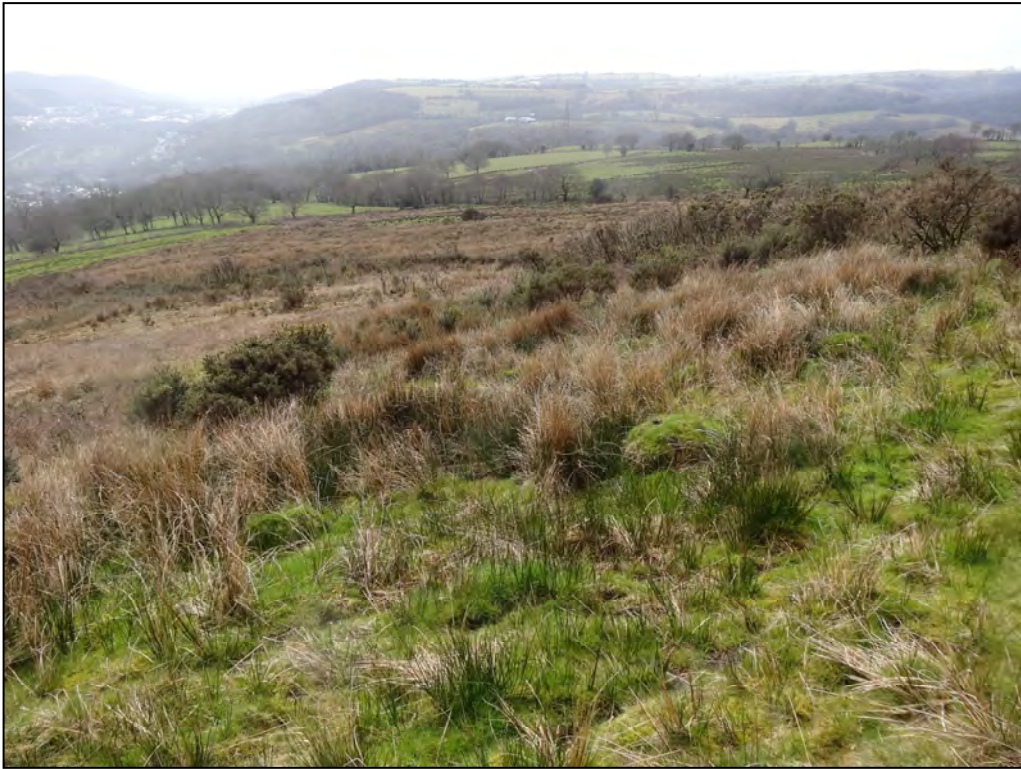
Plate 15: General view across landslide area taken from eastern portion looking southwest.

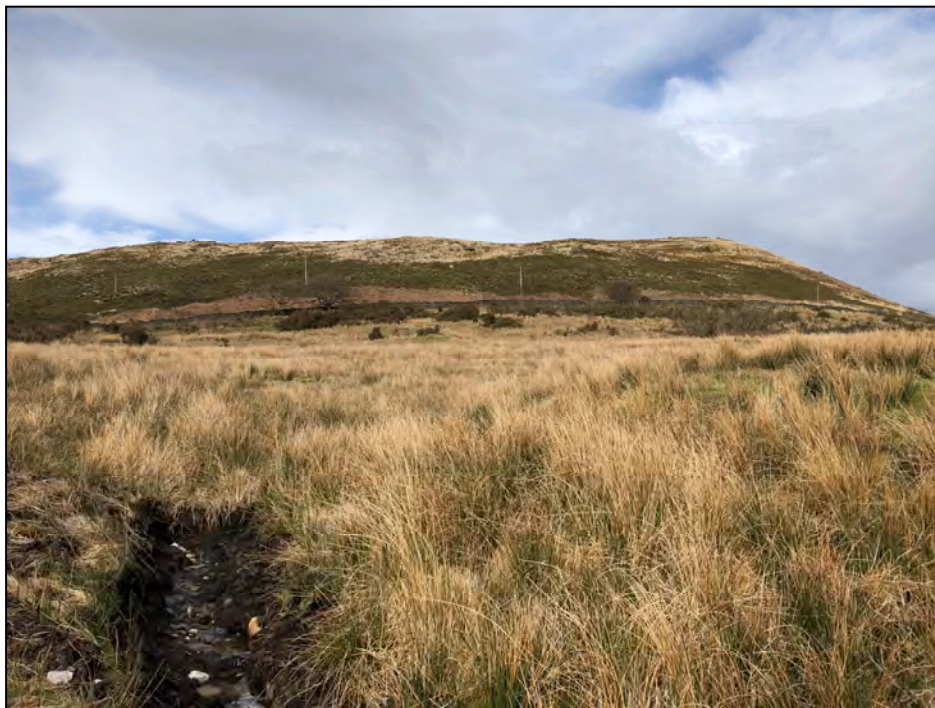
Plate 16: General view of landslide looking north.

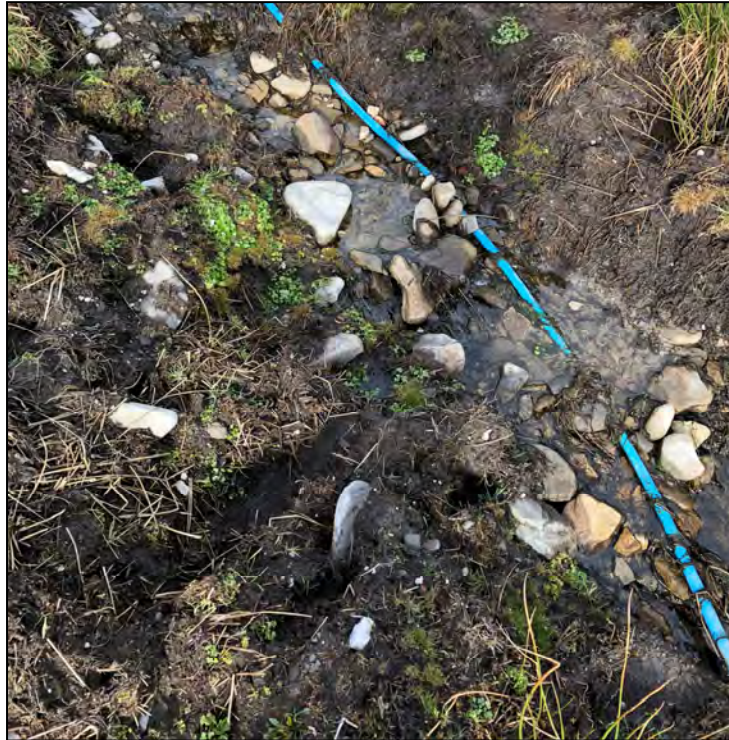
Plate 17: Photo showing suspected gravel and cobbles from Glacial Till within drainage ditch.

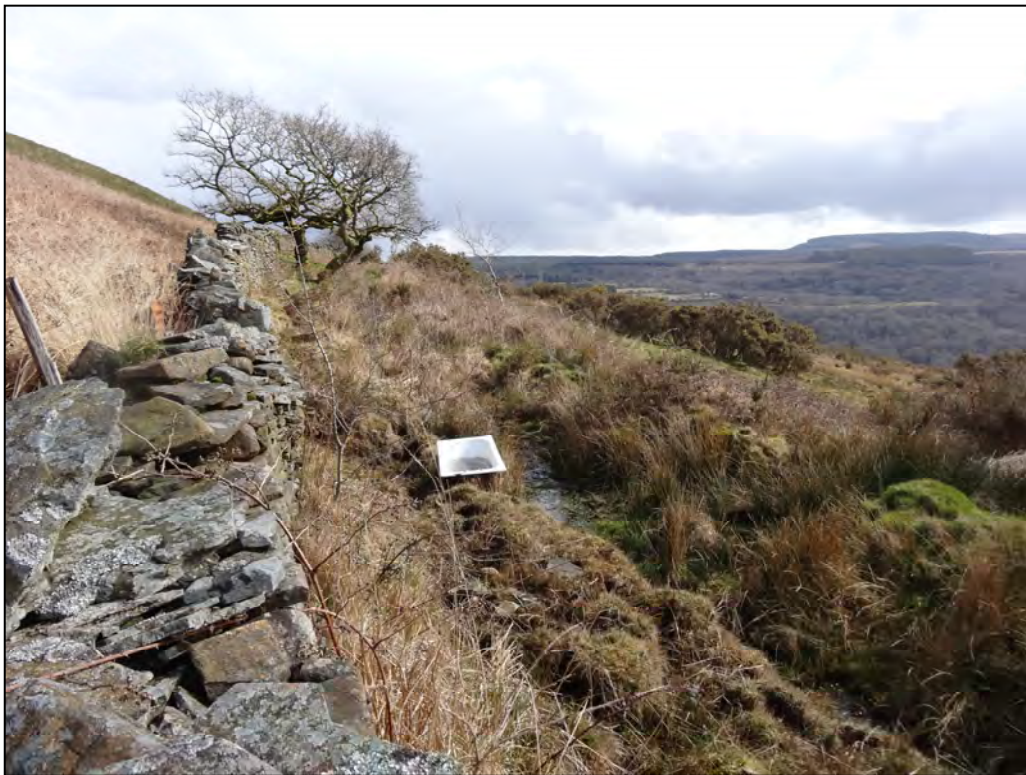
Plate 18: Photo looking east along ditch at the rear of the landslide.
