## **Godre'r Graig Quarry Spoil Tip, Godre'r Graig Drainage Strategy Assessment**

Report Reference: ESP.7234e.08.3972

**Prepared for:**  
 Neath Port Talbot County Borough Council  
 The Quays, Baglan Energy Park,  
 Brunel Way, Briton Ferry,  
 SA11 2GG

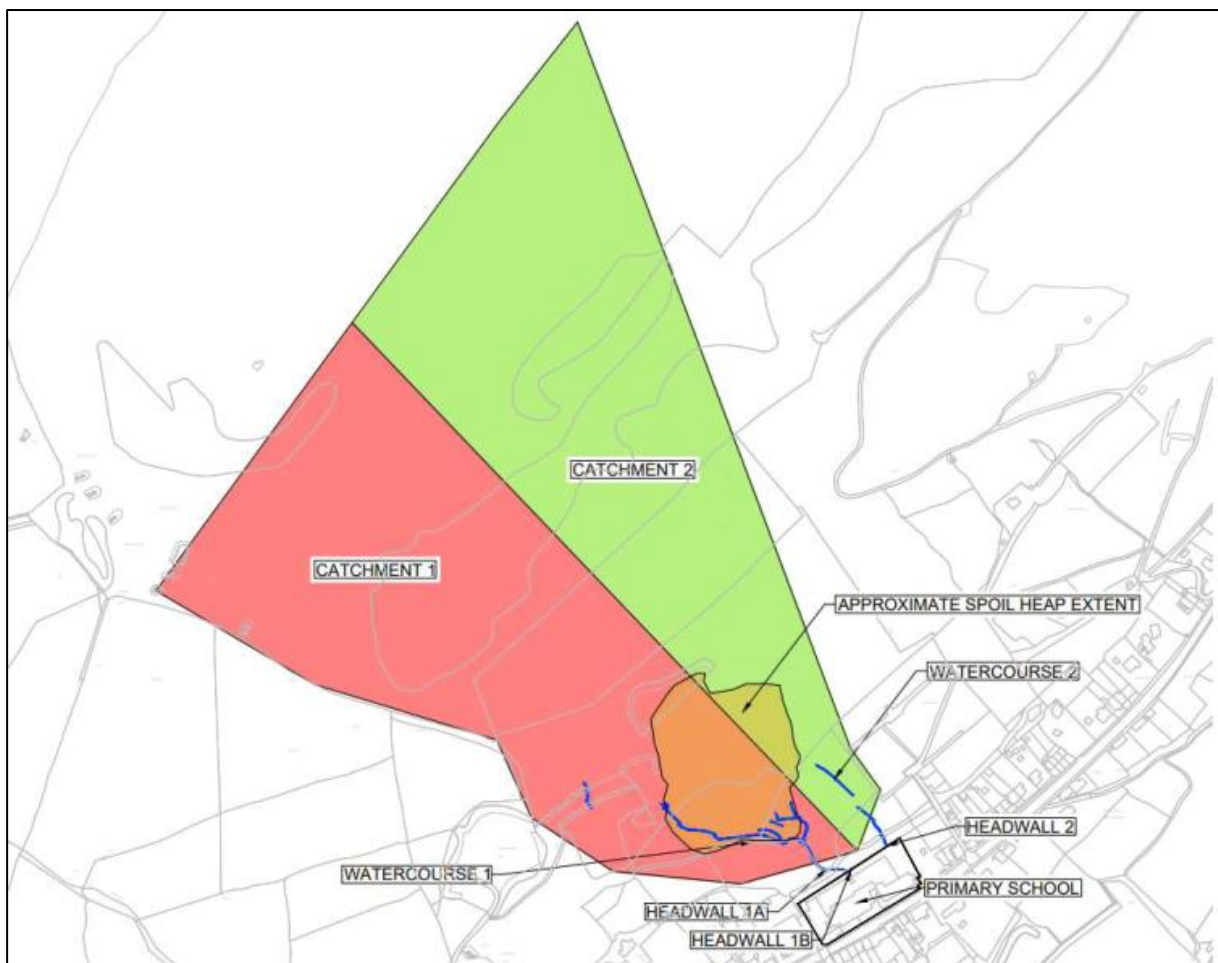
S3 (Watercourse 1 in Insert 2) travels in a south-eastern direction traversing step gradients along natural topography and the Spoil Tip whilst picking up smaller ditches/gulley's before out falling at Headwall 1A and Headwall 1B, serving Catchment 1.

S2 (Watercourse 2 in Insert 2) situated east of the Spoil Tip, travels south to outfall via underground culverts at Headwall 2, serving Catchment 2.

*Insert 2: Catchment Plan of Watercourse 1 (water feature S3) and Watercourse 2 (water feature S2) which outfall at the rear of the school.*

- S3 serves Catchment 1 at approx.. 10.45 Ha, therefore  $10.45 * 16.73 = 173.83$  l/s
- S2 serves catchment 2 at approx.. 10.11 Ha, therefore  $10.11 * 16.73 = 169.14$  l/s

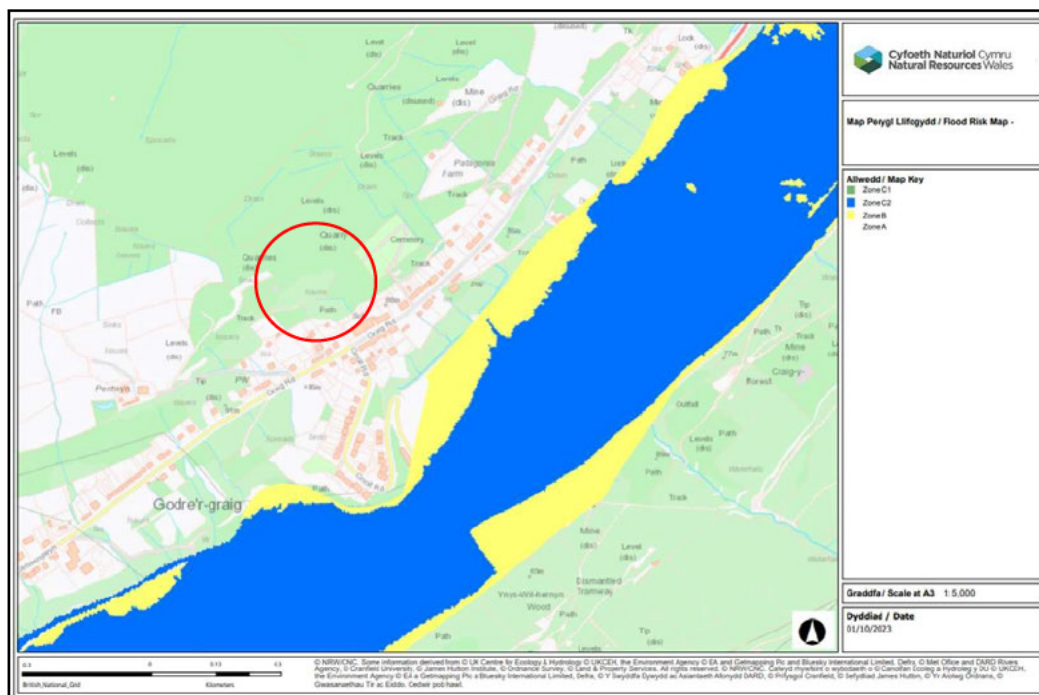
The Natural Resources Wales (NRW) TAN 15 Development Advie Maps (DAM) for the area identifies that these watercourses do not become main rivers. The lower levels of the valley reside within Flood Zones C2 and Zone B whilst the areas in the immediate vicinity of the Spoil Tip are unaffected, as displayed in Insert 3.

Insert 3: Natural Resources Wales (NRW) TAN 15 Development Advie Maps (DAM).

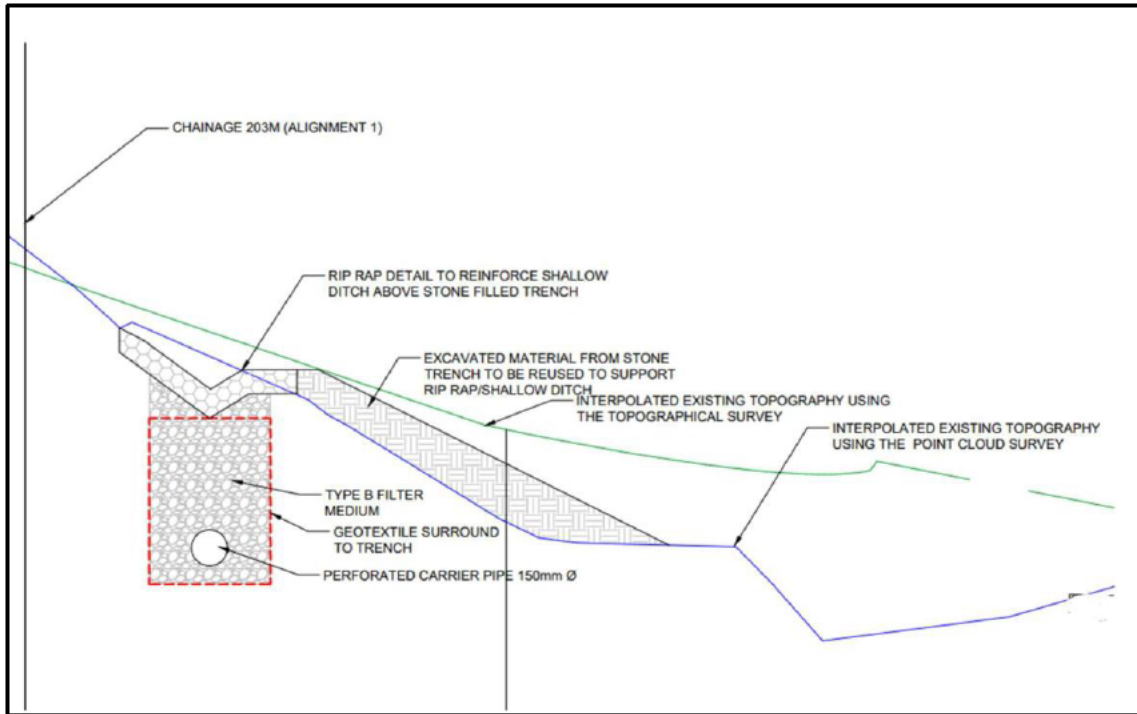
Insert 4: Typical Dispersal Ditch

The construction of formal drainage features in the form of ditches could intercept runoff at the surface that has yet to reach watercourses, and then formally direct to the nearest watercourse. The ditches could be combined as dispersal trenches with underdrains which would act as a barrier and intercept shallow runoff that has infiltrated prior to reaching the ditches.

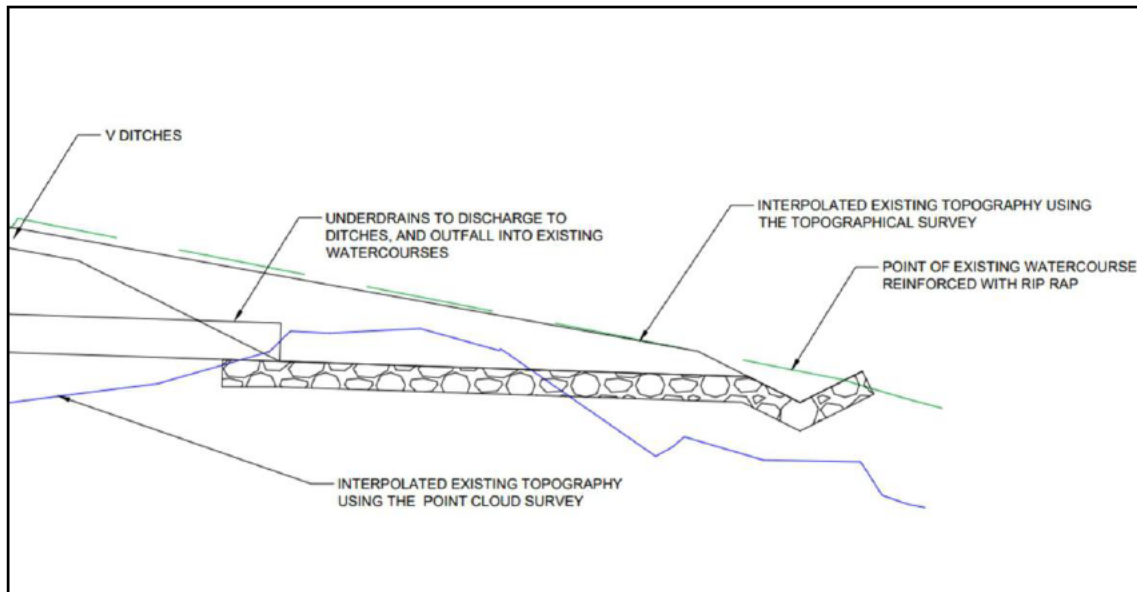
Insert 5: Dispersal Ditch outfall into existing watercourses.

As the topography is steep, these dispersal pipes could also discharge into the existing watercourses, where a rip rap is provided to boost the integrity of the watercourse at branch connections, typical arrangements can be seen below in Inserts 4 & 5. Examples of where drainage options could be adopted are presented as Figure 2.
