Godre'r Graig Village Land Stability Summary

Prepared for:

Neath Port Talbot County Borough Council

Report Reference: **ESP.7234e.7372e.3451.Rev1**

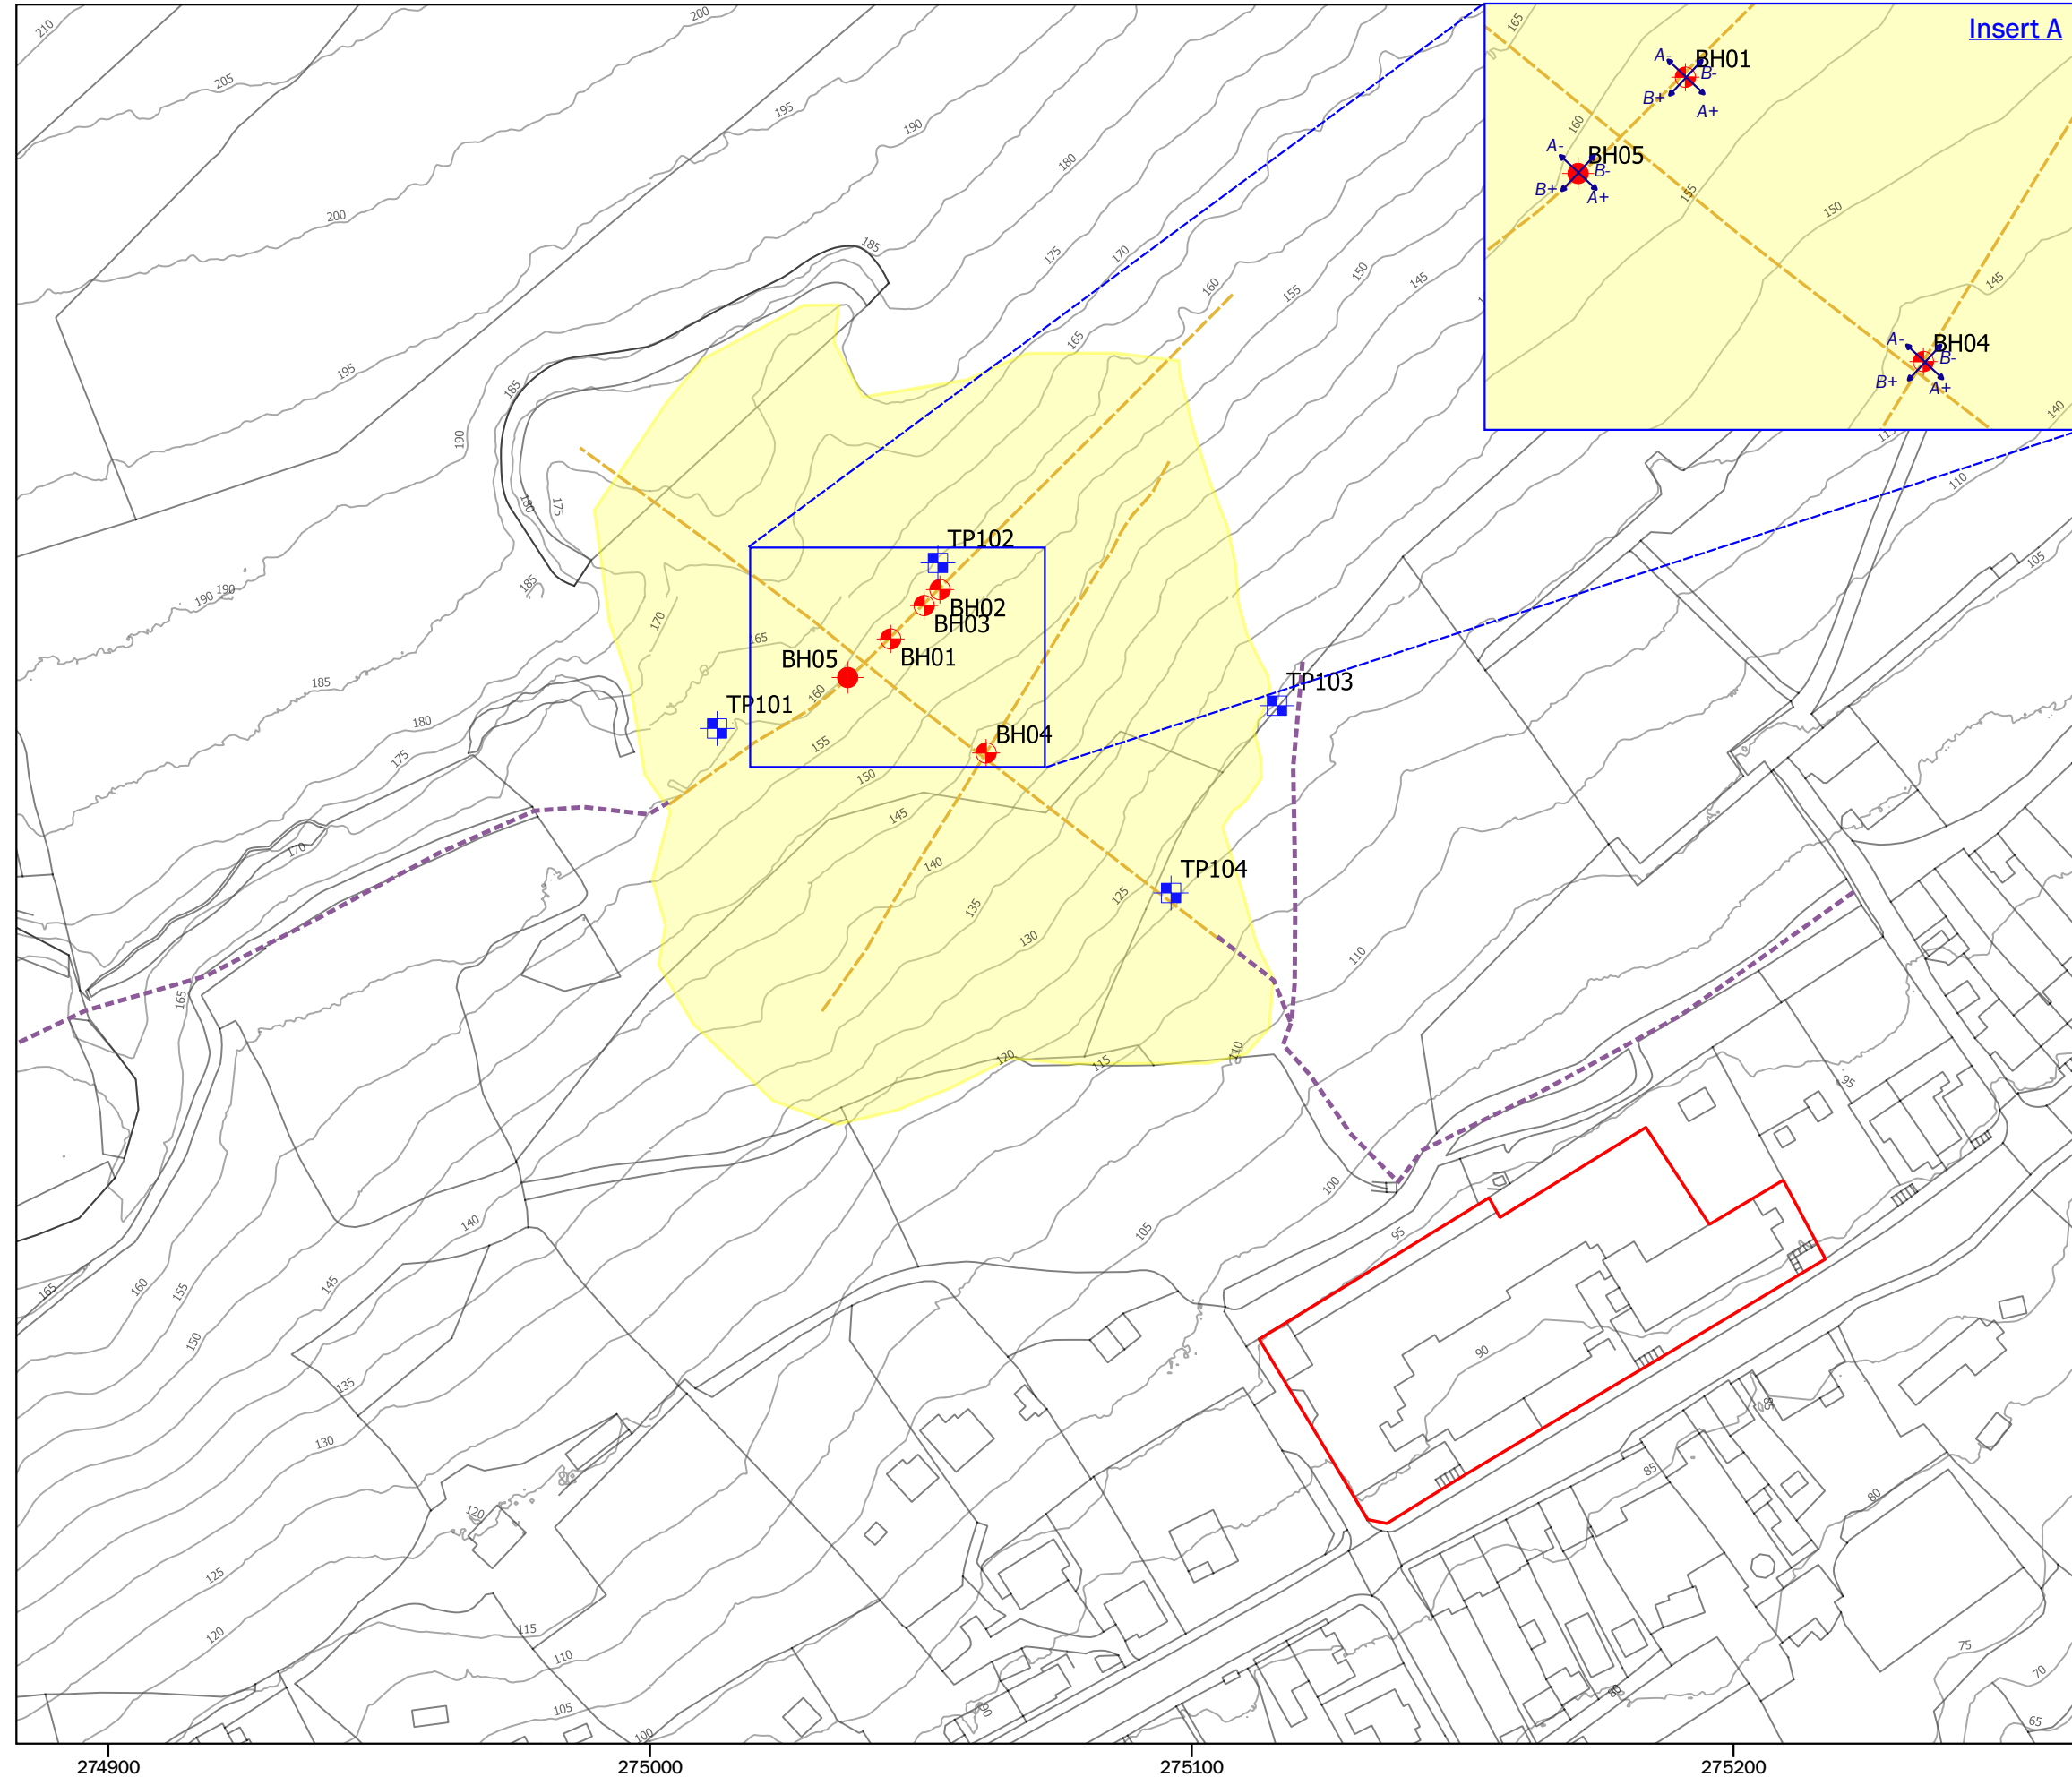
FIGURE 2:
Investigation Point Plan

Groundwater has been observed in the Quarry Spoil Tip and monitoring has shown a variable head of water. The Investigation Point Plan is included here as Figure 2.

Details of inclinometer installations are shown on Insert A

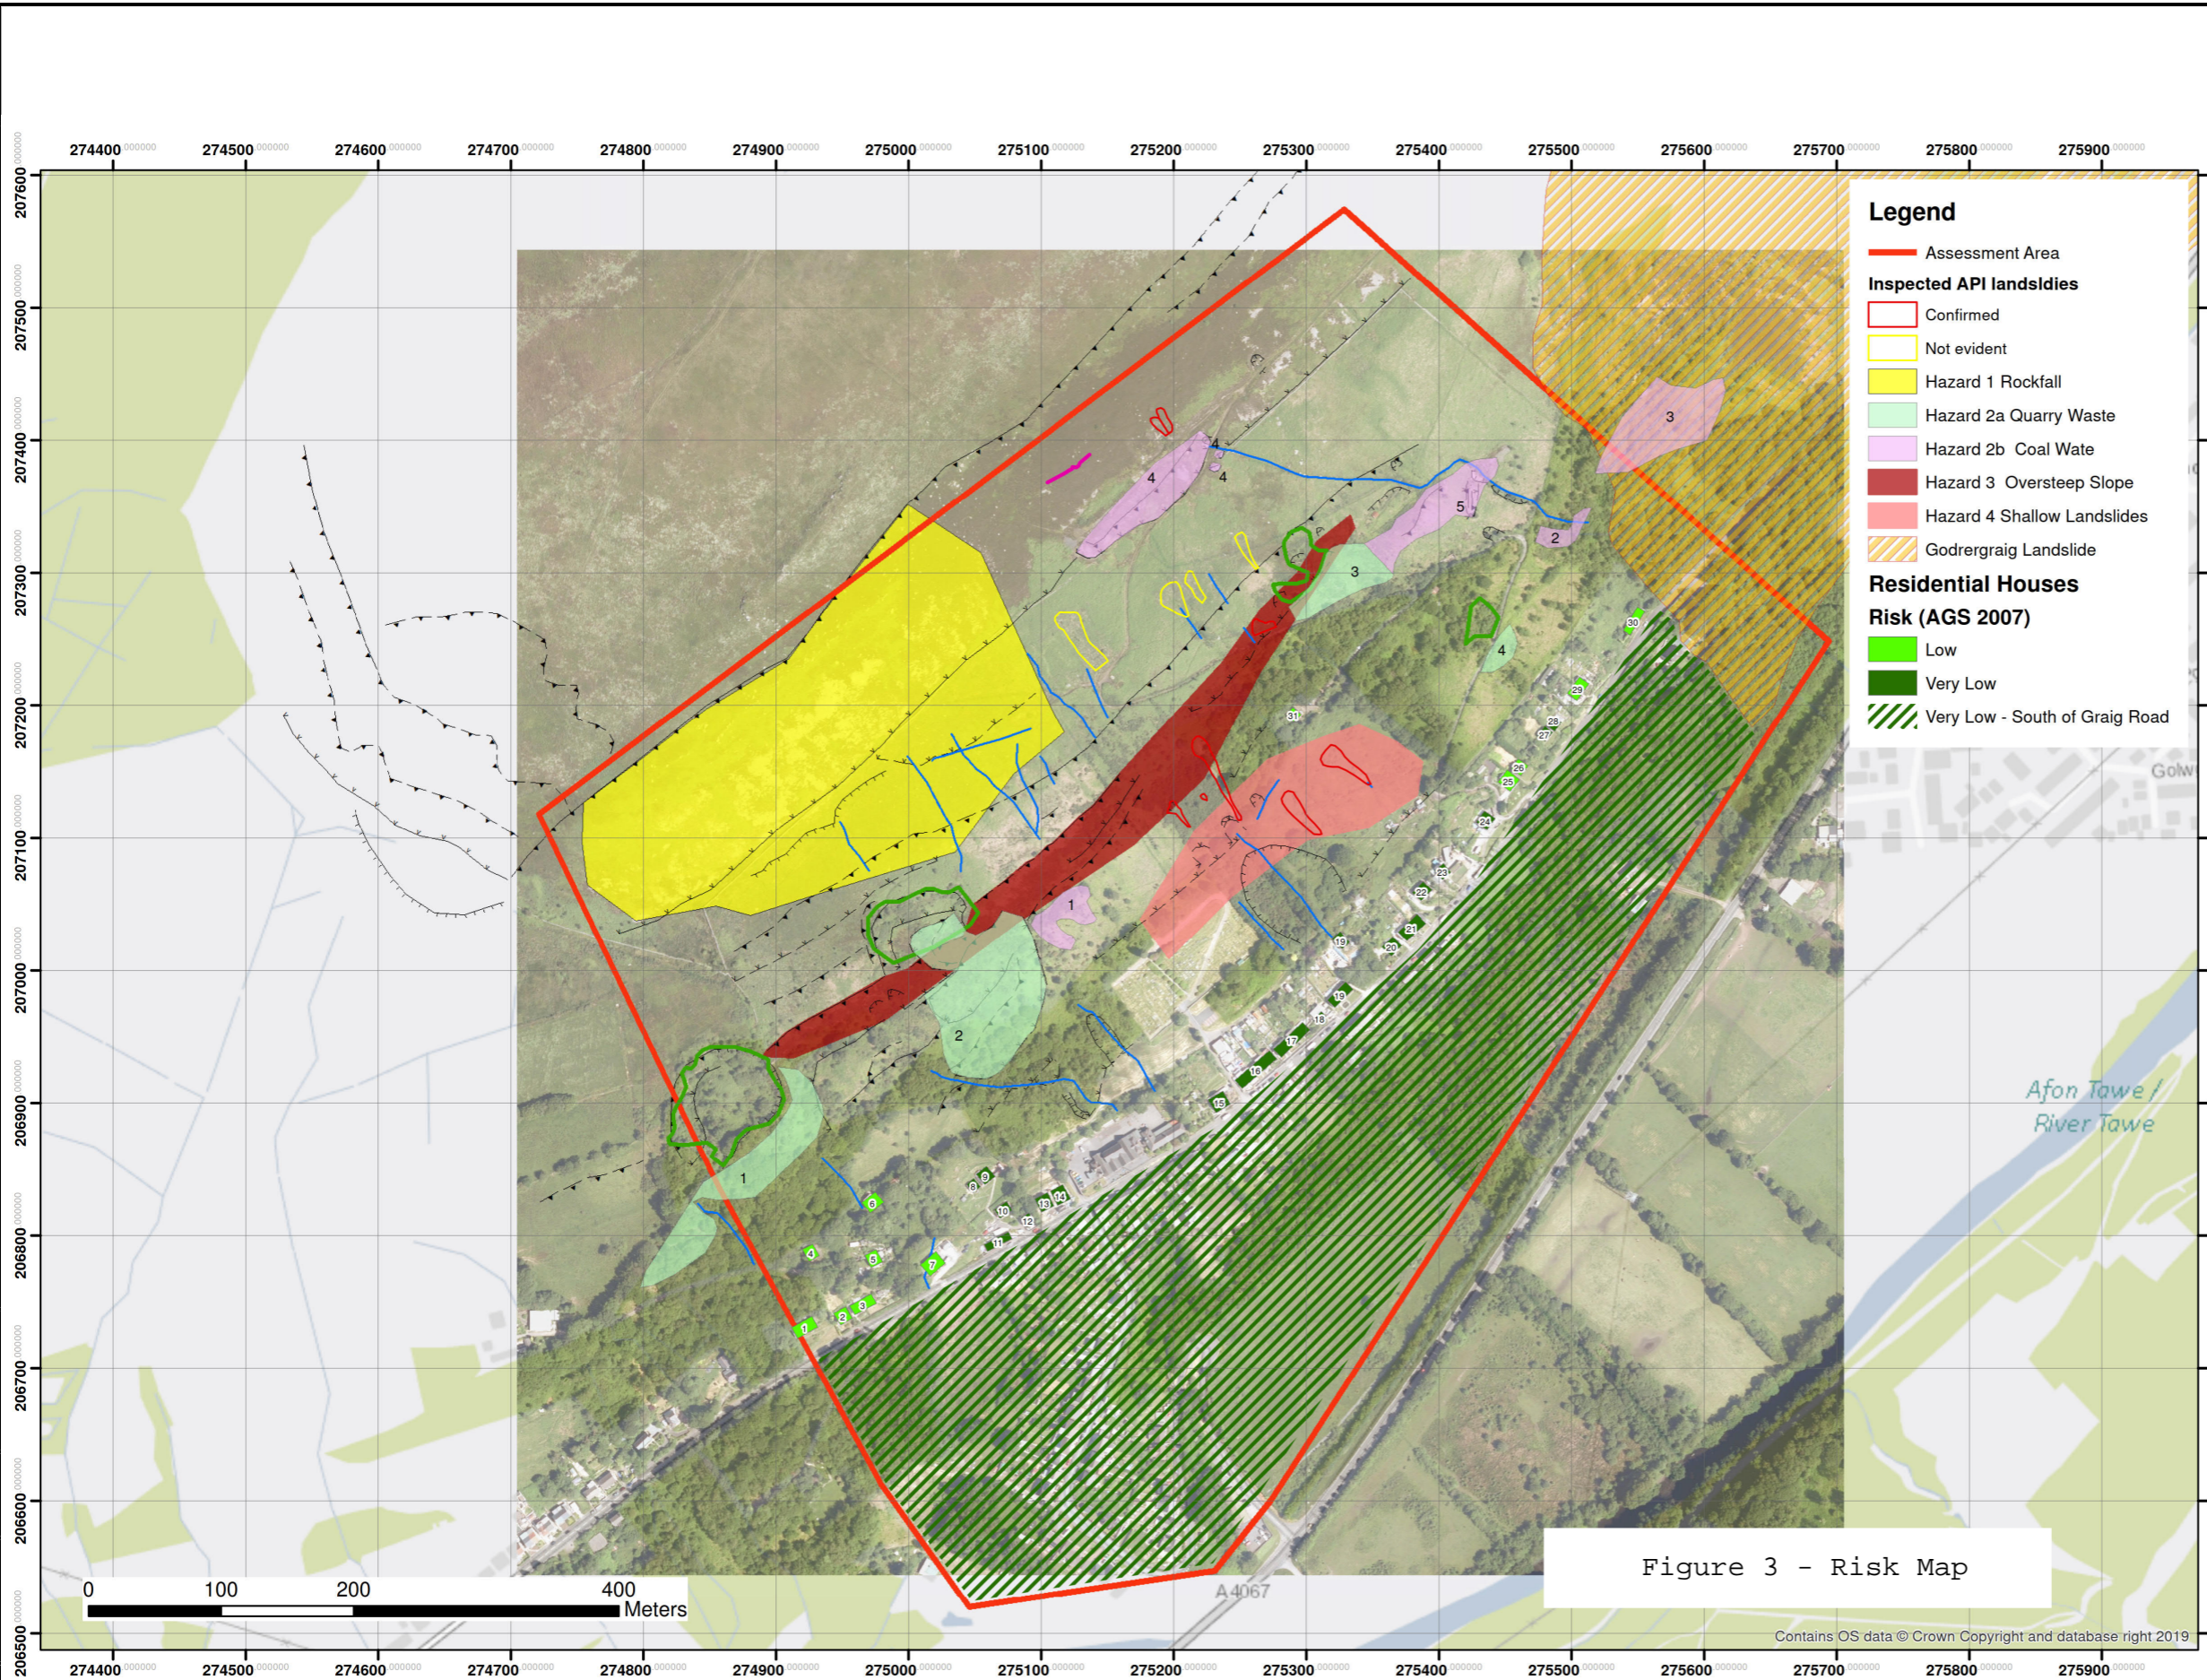
FIGURE 3:
 INITIAL RISK MAP

Based on the above it has been assumed that the risk to residential properties to the south of Graig Road is very low.

No specific assessment has been carried out to assess the risk to members of the public using/visiting the cemetery. However, the cemetery will have a lower usage than the surrounding residential houses. Given that the shallow earth landslides are very slow to slow moving and appear to be limited in depth, risks to cemetery users is likely to be lower.

The assessment has shown that there is a very low to low risk to residential properties in Godre'r Graig, which is "usually acceptable to regulators" (AGS, 2007). No specific remedial or mitigation recommendations are considered necessary. Risks to cemetery users is likely to be lower than the risks to residential properties surrounding the cemetery. The risk to residential properties to the south of Graig Road is very low.

Risks to Cemetery visitors considered to be low. See report for details.
