Report Reference: ESP.7372e.3337

Godre'r Graig Village Preliminary Landslide Hazard and Risk Assessment

Prepared for:
Neath Port Talbot County Borough Council
 The Quays, Baglan Energy Park,
 Brunel Way, Briton Ferry,
 SA11 2GG

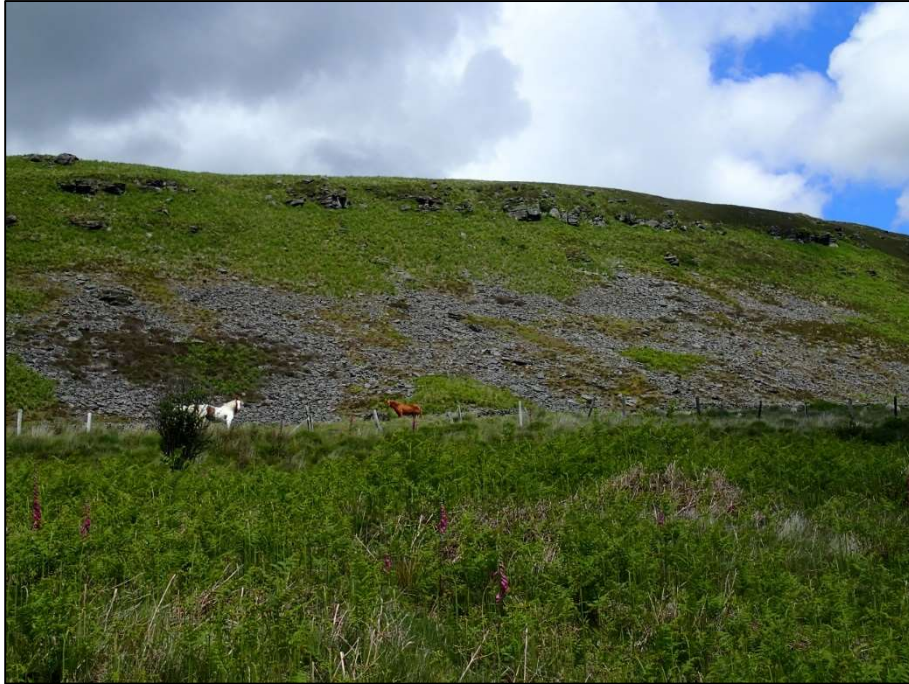
292mOD associated with a linear rock outcrop below which the terrain is steep (25-30°) and associated with limited vegetation and a talus drape. A dry stone wall is present at the toe of the talus slope and there was no evidence of damage to the wall from rock fall nor any evidence of repairs resulting from rock fall. According to the published geological map Mynydd Allt-y-grug and the steep terrain is underlain by Rhondda Sandstone.

Plate 1: Rock outcrop (Rhondda Sandstone) with the associated talus slope below.

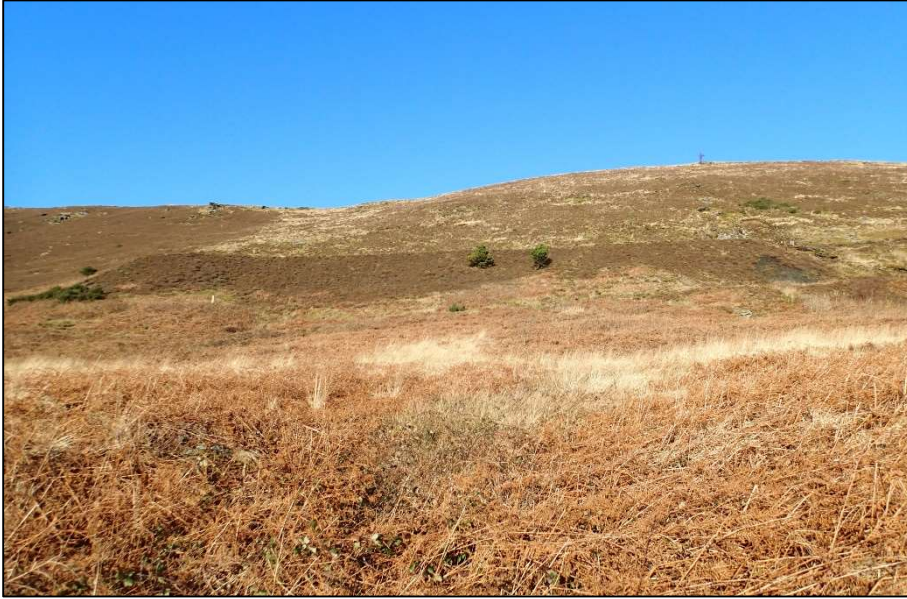
The base of this steeper terrain is marked by a distinct concave break in slope which corresponds to the outcrop of the No 2 Rhondda coal seam at the base of the Rhondda Sandstone. Coal workings are evident in the form of adits and associated spoil in the northeast of the Study Area (Plate 2), with the working of the seam evident in the 1973 and 1975 aerial photographs.

Plate 2: Coal spoil tips associated with the working of the No 2 Rhondda coal seam

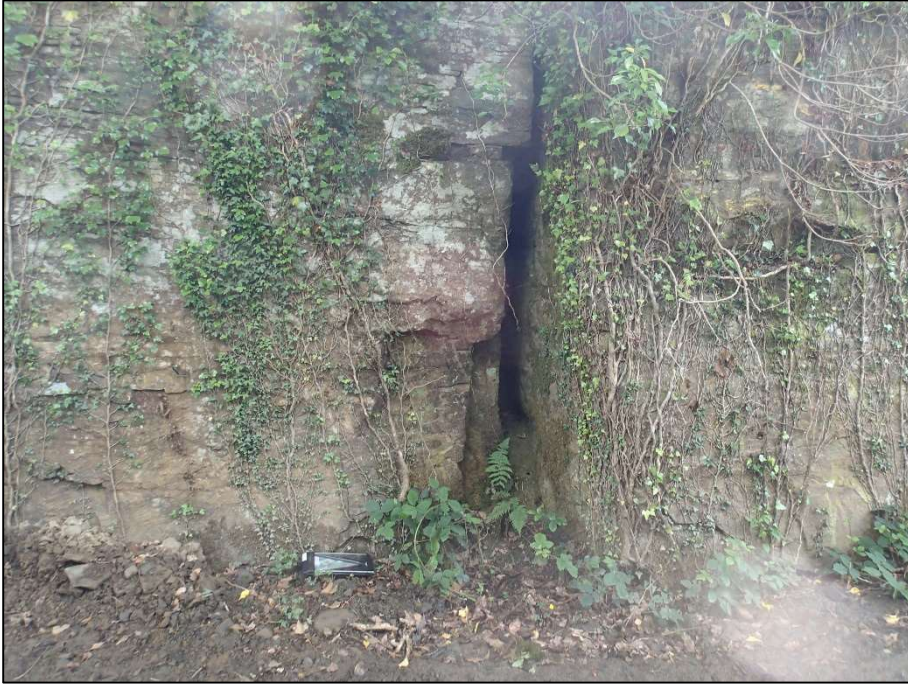
The Llynfi Beds, exposed at Quarry 1, comprise weak to medium strong, thinly bedded, dark grey, partially weathered to unweathered, micaceous sandstone. Bedding dips at 20/185. Two additional discontinuity sets were observed 84/274 with an approximately 1m spacing and 74/018 with a spacing of approximately 5m. The latter set is dilated with an aperture of up to 10cm (Plate 3), reflecting either the effects of mining or cambering.

Plate 3: Bedding dipping from left to right (20/185) the rock face is formed by joint set 84/274 and the dilated joint set is formed by 74/018.

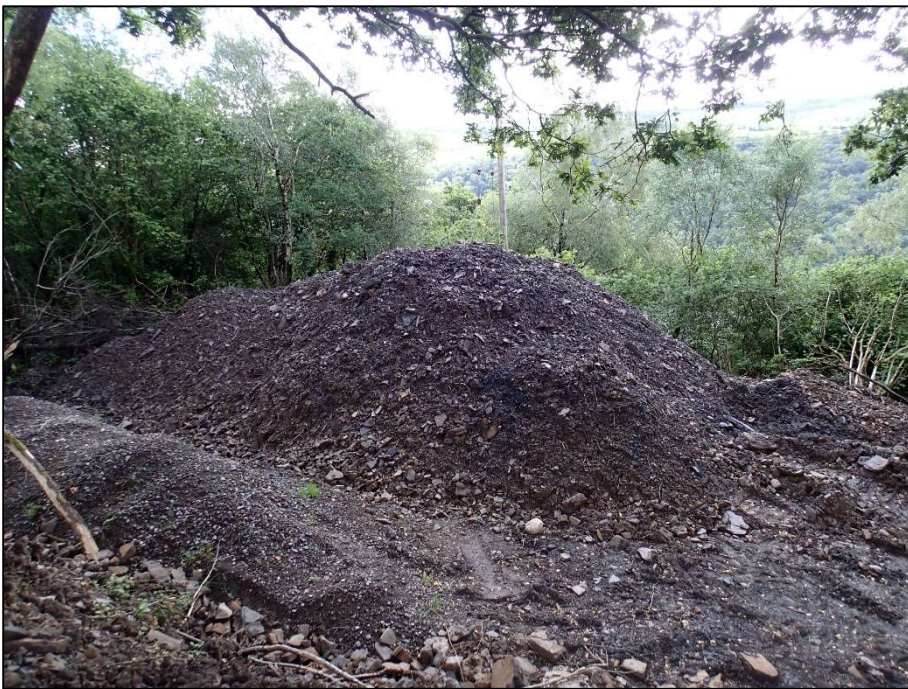
Plate 4: Recently deposited spoil from work in Quarry 1.

Recent works have been undertaken in Quarry 1 with an improved access road constructed. Spoil from this work has been end tipped below the quarry entrance (Plate 4).

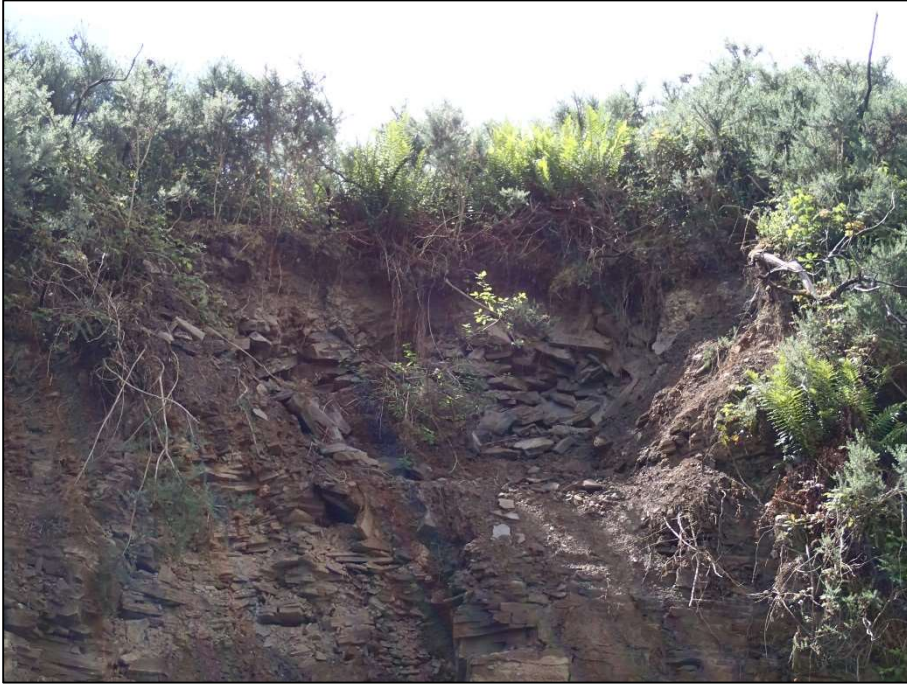
Based on the exposure in Quarry 1, the spoil at this location is likely to comprise interlocking, angular and tabular boulders and cobbles of weak to medium strong sandstone (Plate 5). The spoil associated all the quarries is associated with very dense vegetation, especially brambles limiting access.

Plate 5: Typical spoil exposed in the northwest quarry

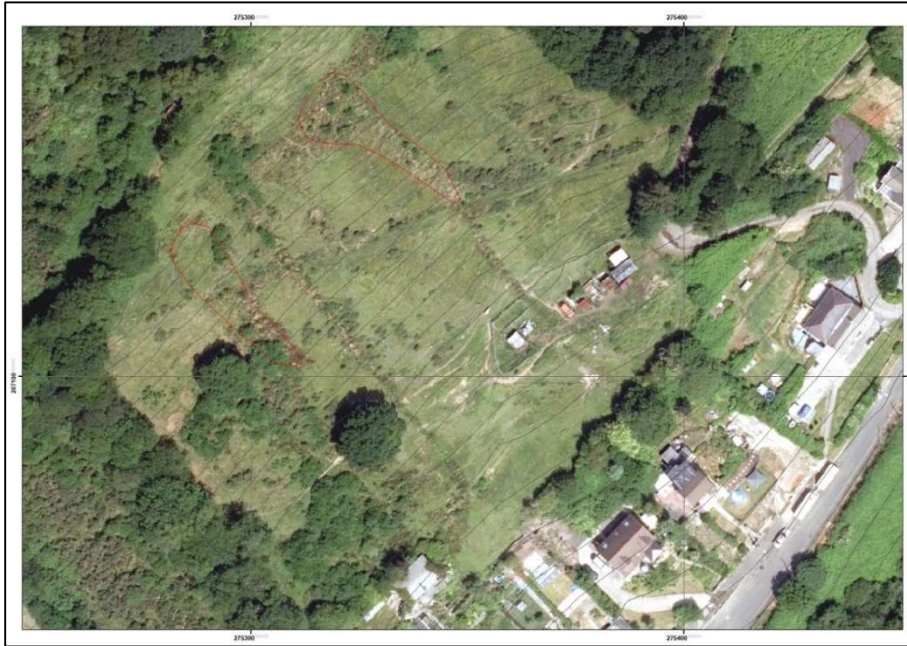
The "shallow slips" recorded on the geological map are not evident on the historical aerial photographs. However, two areas interpreted as being associated with hydrophilic vegetation have been interpreted in the 2013 orthophotograph (Figure 6).

Figure 6: Enlargement of 2013 Orthophotography showing possible landslides identified in the area of "shallow slips" recorded on the geological map.

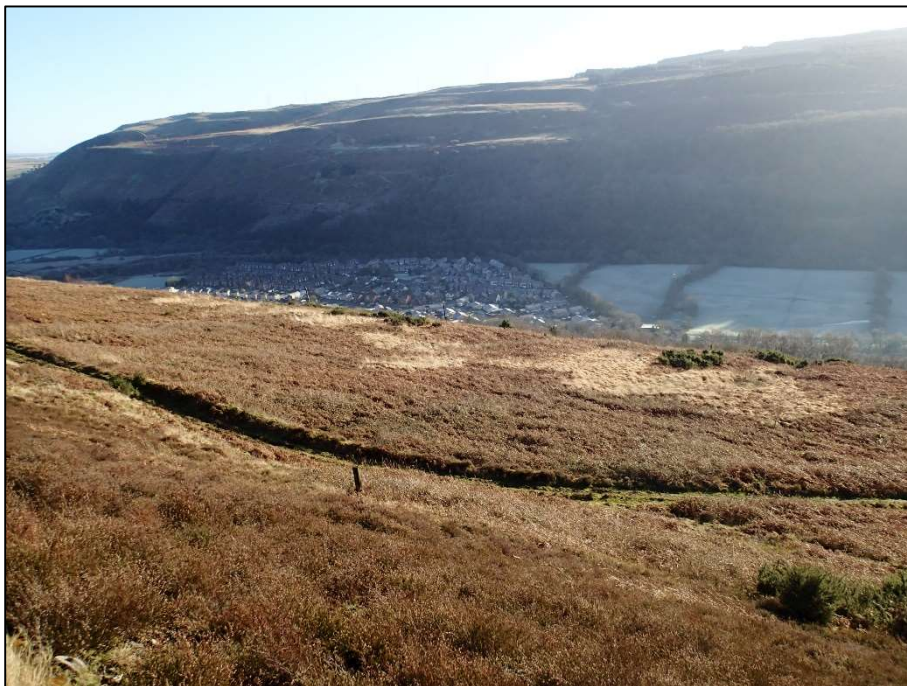
Similar features are evident in the 2013 orthophotograph between the No. 2 Rhondda and Upper Pinchin coal seams in the northeast of the Study Area which also coincides with two possible landslides in the 1952 aerial photographs. However, these areas were inspected and are considered to be related to hydrophilic vegetation with no evidence of landslide processes (Plate 6).

Plate 6: Hydrophilic vegetation below the No 2 Rhondda Seam in the northern part of the study area. No evidence of landslide processes.

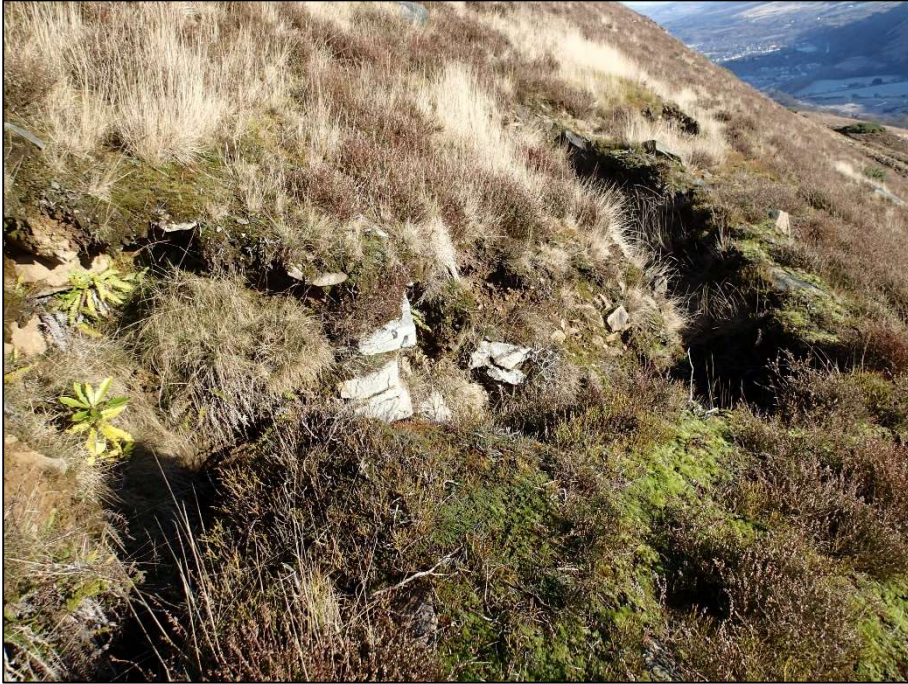
A tension crack is present in the 1978 aerial photographs above the No. 2 Rhondda coal seam, working of which is evident in the 1973 and 1975 aerial photographs. This was inspected and is up to 0.75m wide and 2m deep, extending approximately 40m, and is likely to be the result of localised mining induced instability (Plate 7). At the location of the No 2. Rhondda Seam, a series of former adits are present which are associated with landslides. However, the regolith is thin and the rock mass competent and as a result the landslides are shallow, of small volume (<10m³) and have limited run out (Plate 8).

Plate 7: Tension crack above the No2 Rhondda coal seam likely to be the result of localised mining induced instability.

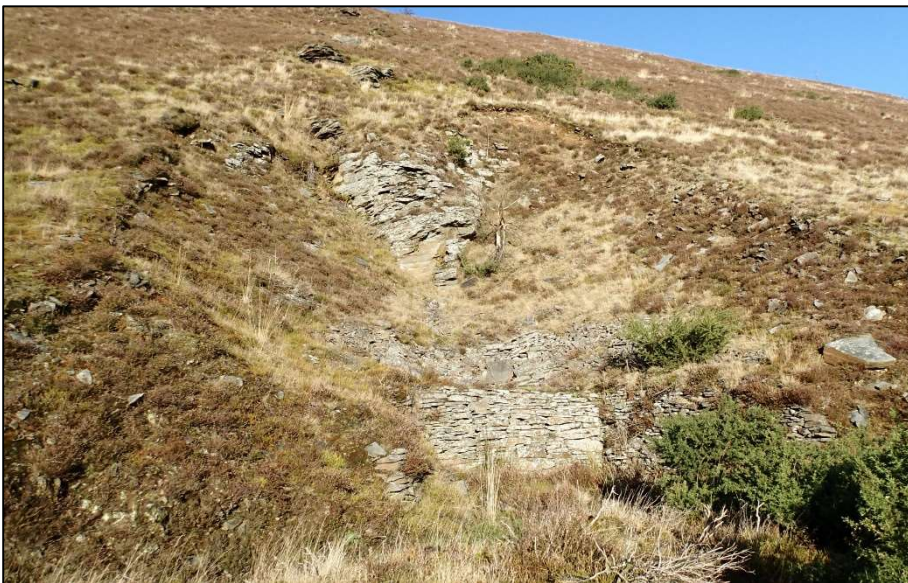
Plate 8: Shallow, small (<math><10\text{m}^3</math>) landslides above former adits in the No 2 Rhondda Seam.

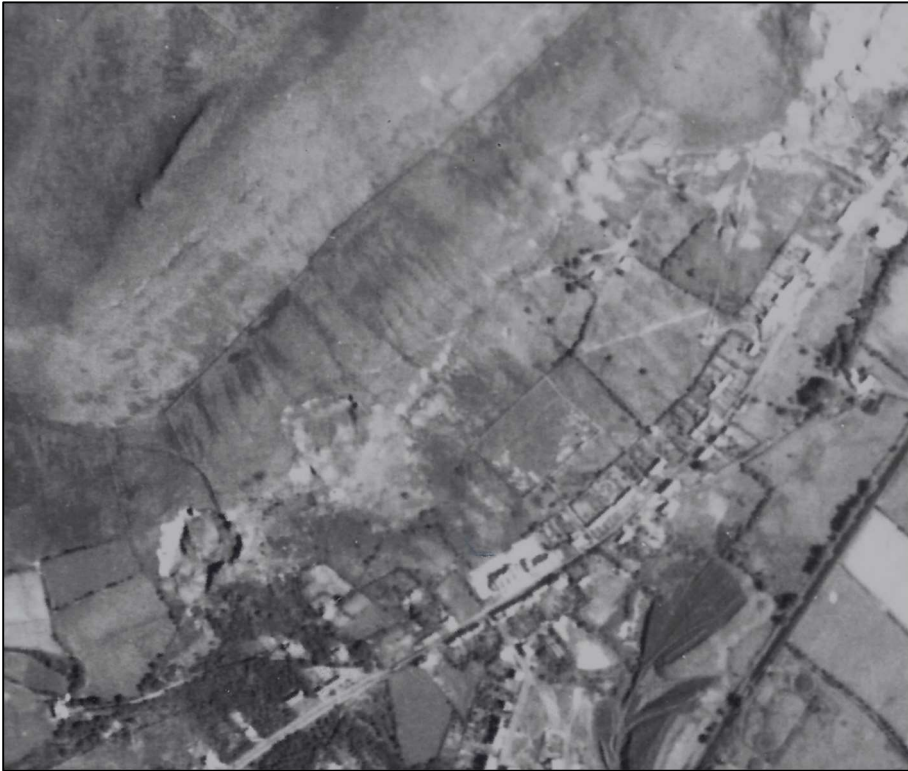
Numerous localised areas of high reflectance are present on the earliest aerial photographs coinciding with the locations of the adits shown on the historical maps and the outcrop of the Lower Pinchin coal seam. The majority of these area are likely to represent disturbed ground associated with the working of the coal seam and not landslides (Figure 7).

Figure 7: Extract of the 1945 Aerial photograph showing high reflectance associated with adits working the Upper Pinchin coal seam

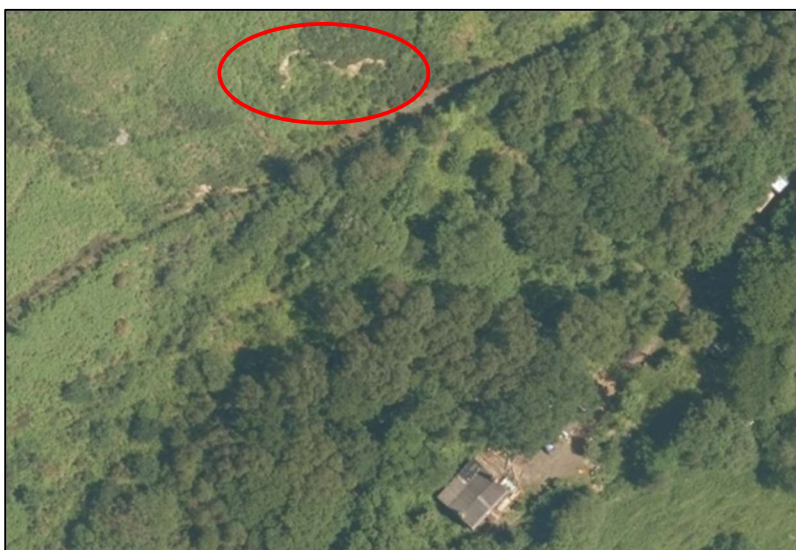
However, a tension crack is evident in the 1997 photographs associated with a former adit associated with the Upper Pinchin. Movement appears to be intermittently ongoing, with the tension crack being larger in extent in the 2013 orthophotograph (Figure 8). The landslide is associated with a drainage line from up slope. Whilst dense vegetation and steep slope precluded a detailed inspection, no rock outcrop was observed and a series of tension cracks are present upslope of the main scarp.

Figure 8: Tension crack (circled) above former adit location

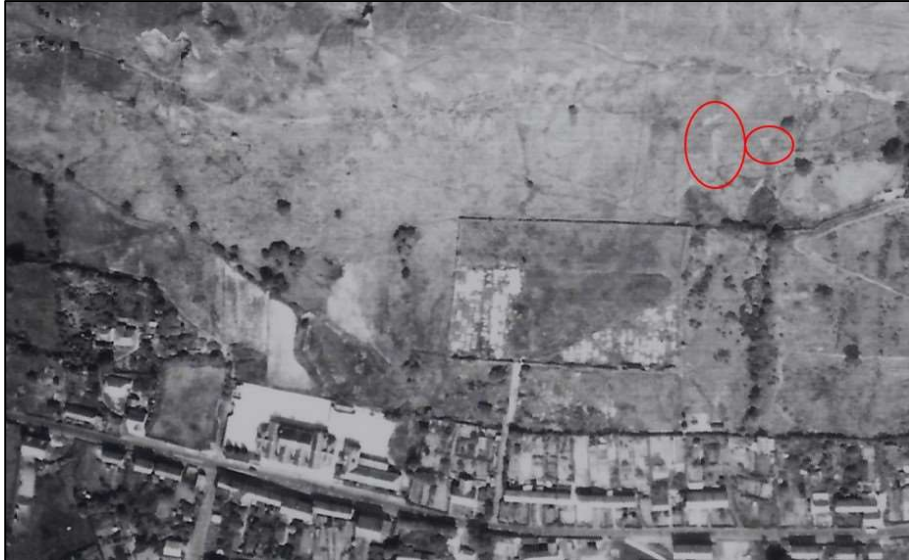
Additional features identified as possible landslides and depression in the 1952 aerial photographs are associated with relatively deep (2-3m high) depressions which are probably the location of former adits (Figure 9). The high reflectance evident in the 1952 aerial photograph is considered to reflect localised instability associated with the over steep adit sides. The longest run out based on the API is approximately 27m.

Figure 9: Extract from 1952 photograph with possible landslides circled

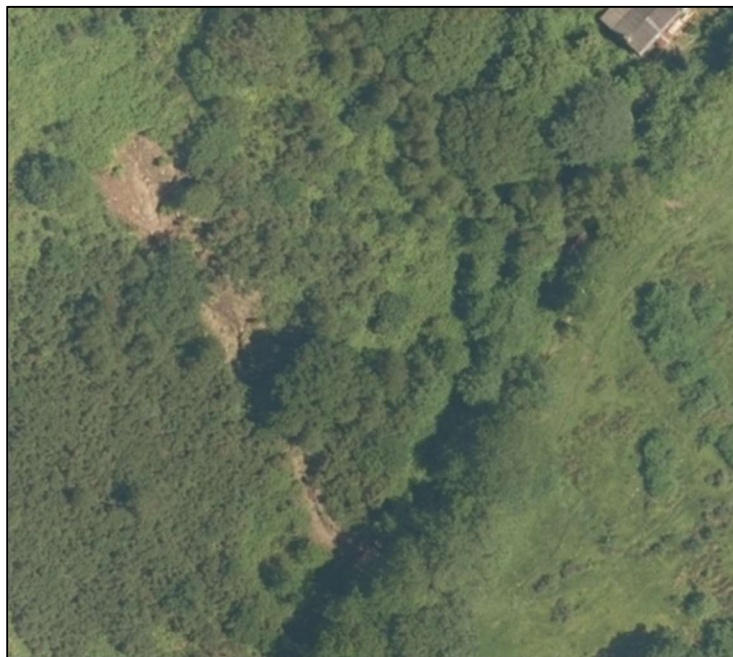
Figure 10: 2014 Landslide

In the 2014 orthophotograph a recent (post 2013) landslide has occurred (Figure 10), again close to a former adit location. The run out from this landslide is 70m with an angle or reach of 26°.

It would appear that the rock mass associated with the Upper Pinchin is relatively weak and the over steep ground associated with the former adits acts as a loci for slope movement which can ultimately result in complete detachment and landslide run out.

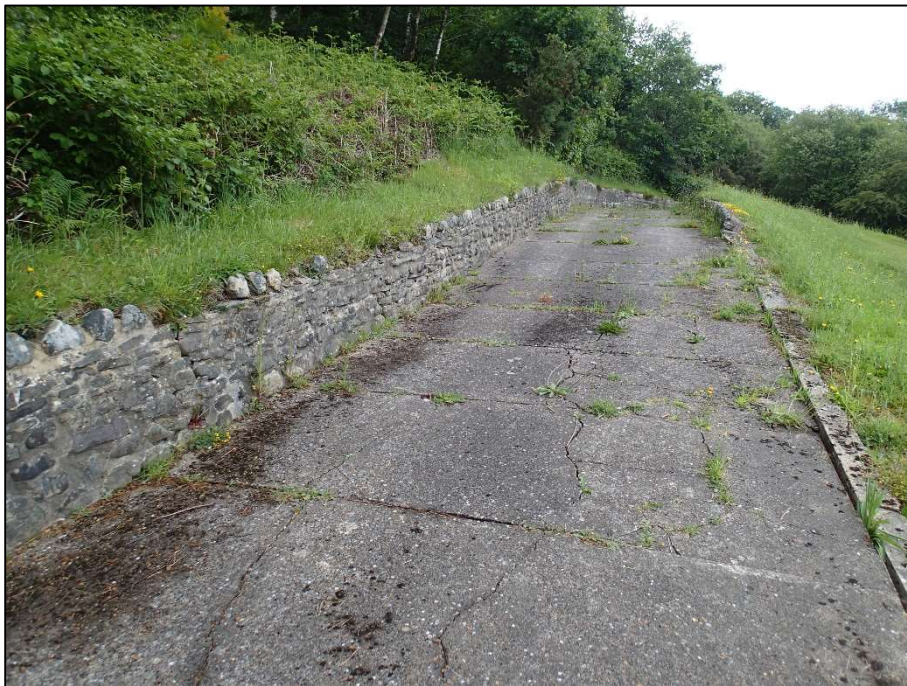
The area of “shallow slips” recorded on the geological map comprises a series of shallow depressions associated with springs and hydrophilic (marshy) vegetation. A small cut slope 0.2m – 0.3m high, associated with a former tramway crosses the toe of these features. This exposes of clayey silt with occasional sub angular, medium to coarse gravel which has been interpreted as colluvium. There is no evidence of movement in this cut slope. Shallow (<0.2m) earthslides/earthflows may be associated with these depressions. This terrain extends across the Study Area to the southwest and instability, in the form of a distressed road (Plate 9) and a shallow depression, was noted within the cemetery at approximately the same level. At the rear of the School there was no evidence of landslides or distress. However, terracettes suggesting very shallow soil movement and wet ground is present.

Plate 9: Distress evident in the upper part of the cemetery.

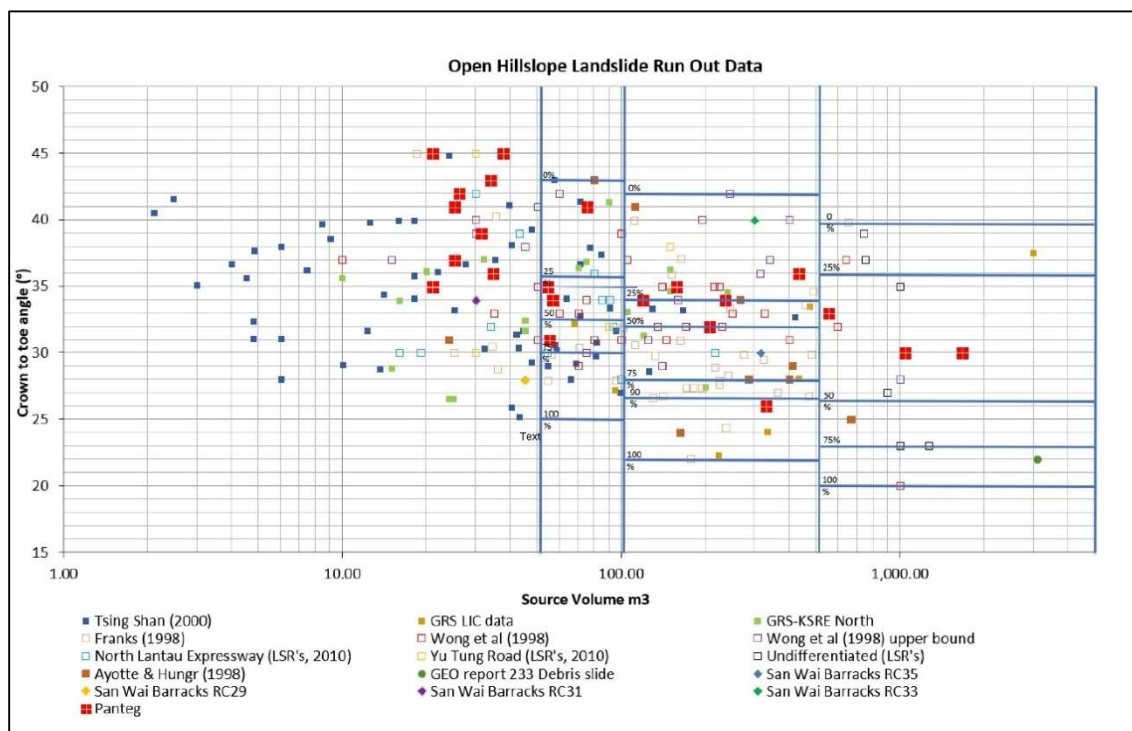
There is limited data available for run out and so data for debris avalanches from Hong Kong has been adopted (Figure 13). Assuming the landslide is between 100m^3 and 500m^3 suggests a maximum run out of 23° with 90% stopping by 27° . Landslide run out data from the Pantteg landslide hazard assessment (PEGS, 2018) is also in Figure 13. These failures primarily involved colliery spoil. Based on this data It has been assumed that the probability of run out will be 1.0 for 27° or more, 0.1 for 27° - 23° , 0.01 for 23° - 20° (20° being the longest recorded run out) and 0 for $<20^\circ$.

Figure 13: Landslide runout data from Hong Kong together with run out data from Pantteg (PEGS, 2018)
