Godre'r Graig Primary School, Godre'r Graig Preliminary Landslide Hazard and Risk Assessment Report Reference: ESP.7234e.3221

Godre'r Graig Primary School Preliminary Landslide Hazard and Risk Assessment

Prepared for: Neath Port Talbot County Borough Council

Report Reference: ESP.7234e.3221

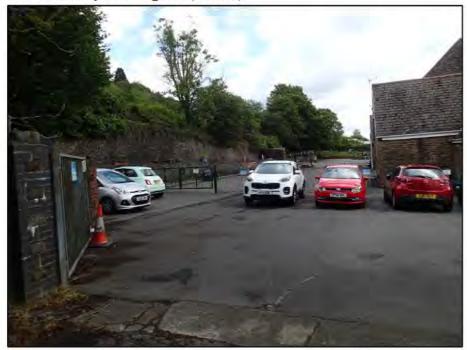
The elements at risk are the school building (temporally and spatially fixed) and the population of the school (temporally and spatially variable). The school was built between 1899 and 1918 (Section 4.3) and is of masonry construction. The school playground is located at the rear of the school below a masonry retaining wall (Plate 1).

Plate 1: Retaining wall between the school playground and the natural slope.

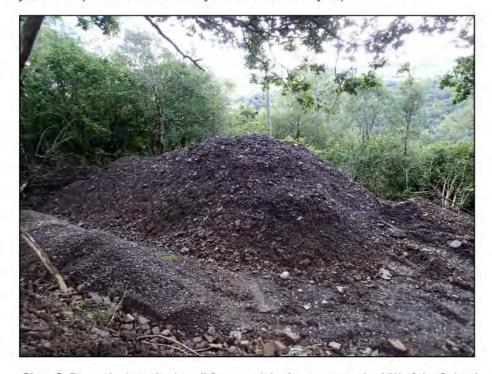
Plate 6: Recently deposited spoil from work in the quarry to the NW of the School.

Recent works have been undertaken in the NW quarry with an improved access road constructed. Spoil from this work has been end tipped below the quarry entrance (Plate 6).

As discussed in Section 3.2.1, recent evidence that quarrying has taken place at Cwar Pentwyn (Plate 6). A review of the ownership, activities, permissions and conditions should be undertaken.

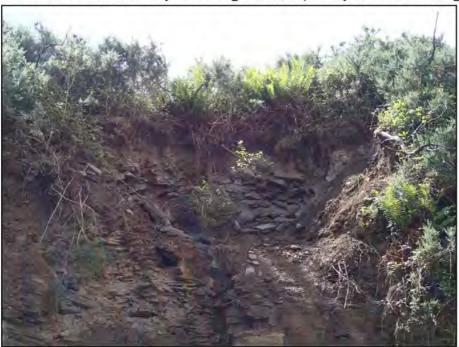
Based on the exposure in the NW quarry, the spoil comprises interlocking, angular and tabular boulders and cobbles of weak to medium strong sandstone (Plate 7). The spoil associated with both quarries is associated with very dense vegetation, especially brambles limiting access.

Plate 7: Spoil exposed in the NW quarry

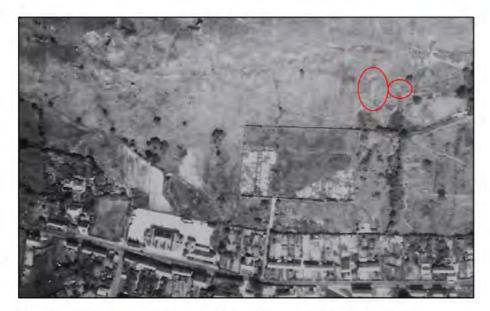
There was very limited evidence for previous landslides from the API. These possible landslides were tentatively identified in the 1952 aerial photographs (Insert 5). Three arcuate depressions are located below these features that, based on the API, were considered to have been possible formed by landslide processes.

Insert 5: Extract from 1952 photograph with possible landslides circled

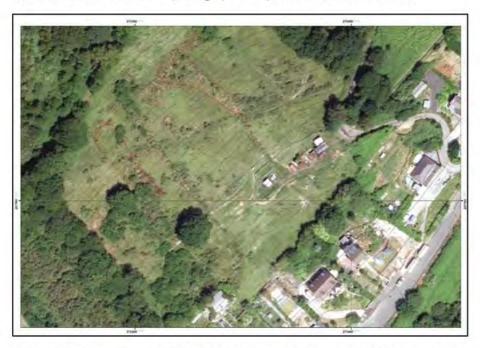
The "shallow slips" recorded on the geological map are not apparent on the historical aerial photographs. However, two areas interpreted as being associated with hydrophilic vegetation are evident in the 2013 orthophotograph (Insert 6).

Insert 6: Enlargement of 2013 Orthophotography showing possible landslides identified in the area of "shallow slips" recorded on the geological map

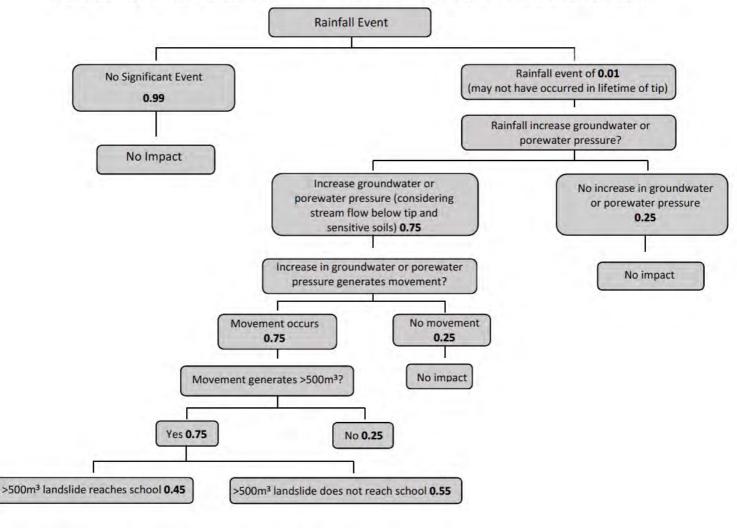
Impact from debris avalanche initiating from quarry spoil.

As discussed in Section 7.1, an event tree has been used to provide a qualitative, indicative value of approximate annual probability for such an event occurring. The event tree is presented below.

Using the probabilities assigned in the event tree, it suggests that the estimated annual probability of a landslide hitting the school is 0.0019, or 1.9×10^{-3} . Using Table 6 above, this annual probability correlates to a 'possible' likelihood i.e. the event could occur under adverse conditions over the design life. Table C7 in the Commentary of the AGS guidelines provides some further information on a $\times 10^{-3}$ order of magnitude, which is that 'the occurrence of the condition or event is not observed in the available database. It is difficult to think about any plausible failure scenario; however, a single scenario could be identified after considerable effort'. We consider that this statement has similarities with our assessment for Hazard Type 2, as this observations made on site and some probable conditions (such as the coarse free draining nature of the tip) suggest that instability may not be possible, however, these conditions are unproven and cannot be assumed.

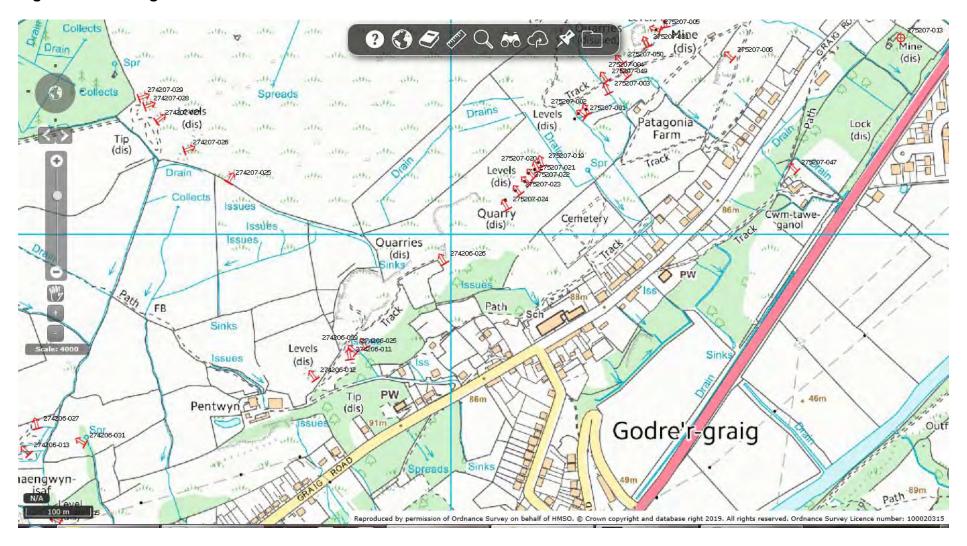
Figure 10 - Mining Features

There are 10 recorded mine entries within the site boundaries. The locations of these are shown on Figure 10, with details given below:

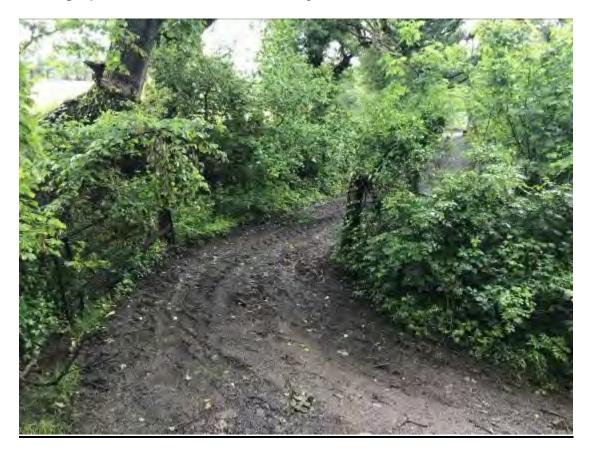
Photograph 1 – Access road to Pentwyn Farm

Inspection on the 13th June 2019 began at the south-western extremity of Site 1, at the access track leading to Pentwyn Farm and the entrance to Cwar Pentwyn (photographs 1 and 2). It was noted that flows from the mine adits above were entering the roadside drainage channel along the Pentwyn Farm access road (photograph 3). The quarry access track was well used and mounds of what appeared to be quarried material were present over the location of the mine adits and the colliery spoil tip to the south of the track (photographs 4, 5 and 9).

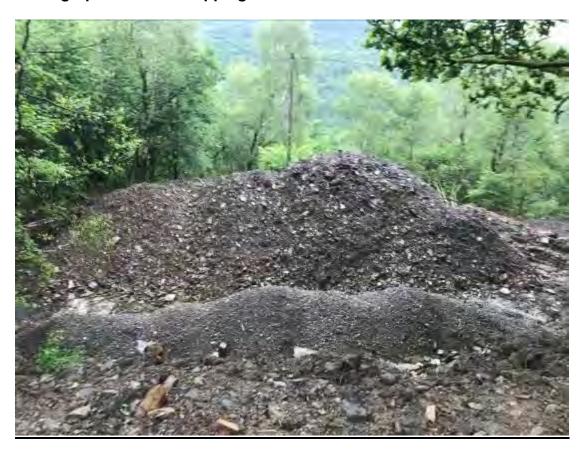
Photograph 5 – Recent tipping of material at Site 1

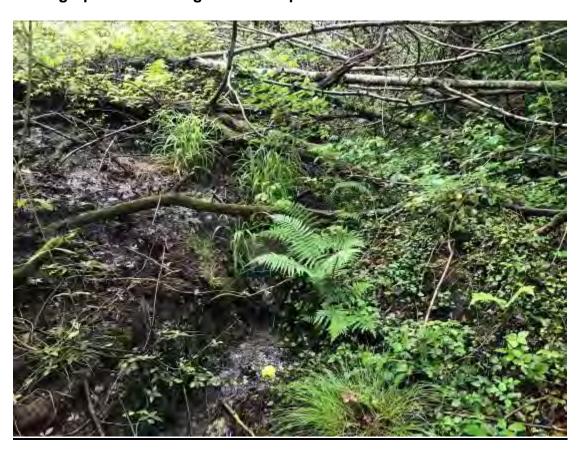
The recorded adit positions in this area were evidenced by flows entering a partially lined channel, conveying water to the roadside channel along Pentwyn Farm access road (photographs 6 and 7).

Photograph 6 – Discharge from adit positions at Site 1

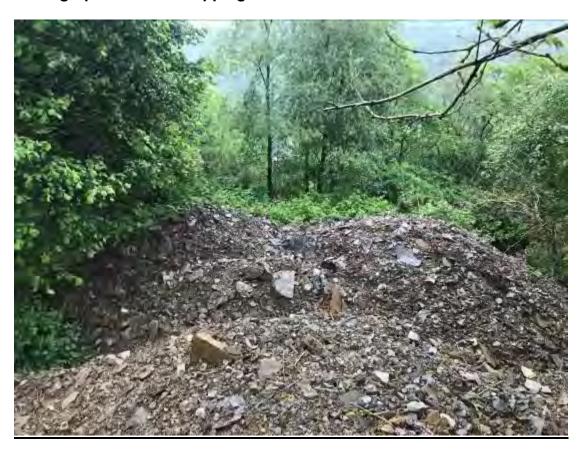
Photograph 9 – Recent tipping of material at Site 1

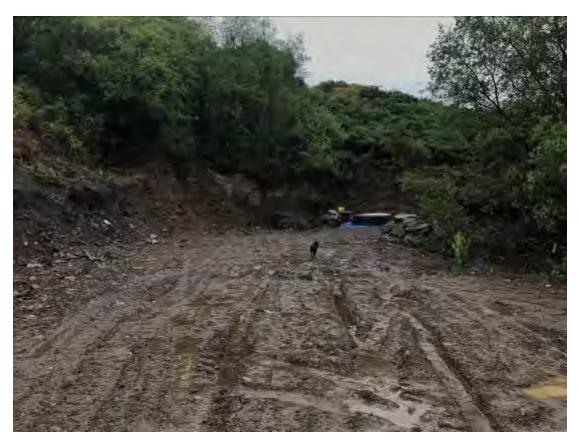
Photograph 12 – Pentwyn Quarry floor

The inspection then viewed the floor and high walls of Cwar Pentwyn. Recent quarrying activity appeared to have taken place, with mounds of excavated material present. Evidence of human activity was also observed as a 'Lazy Spa' type pool, tent and camp bed were present, along with electricity extension cables leading downslope toward the properties named 'Glanderi' and 'Darren View' (photographs 11 to 16).

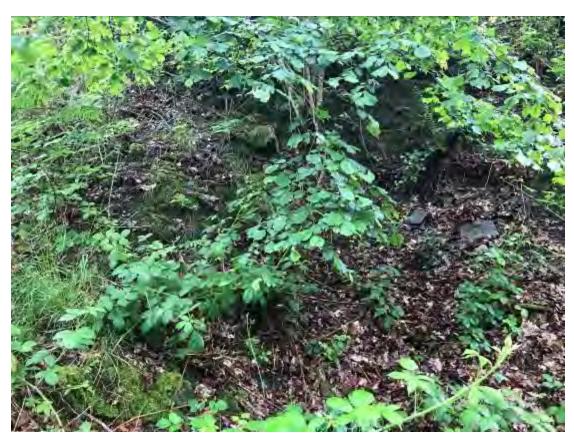
Very little evidence of recent instability was observed, with the exception of a small degraded shallow slip at approximate NGR 274910E 206861N (photograph 20) and some areas of soil creep.

Photograph 20 – Small slip on flank of Site 1

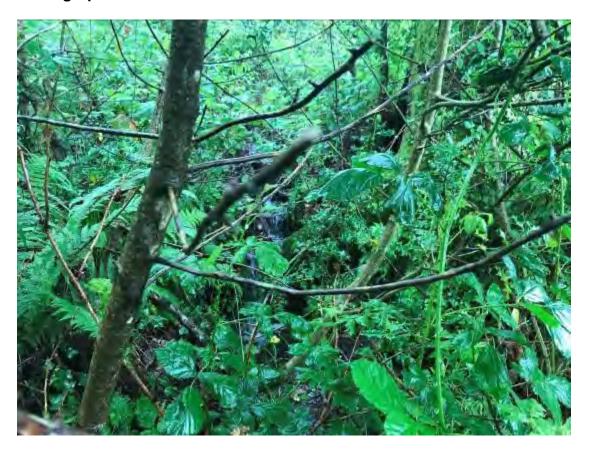
A spring was observed emanating from the vicinity of mine adit reference 274206-026 at NGR 274988E 206957N (photograph 21). The spring was observed as forming a small marshy area, subsequently flowing overland and downslope in a south-easterly direction.

Photograph 21 – Minor watercourse at head of Site 2

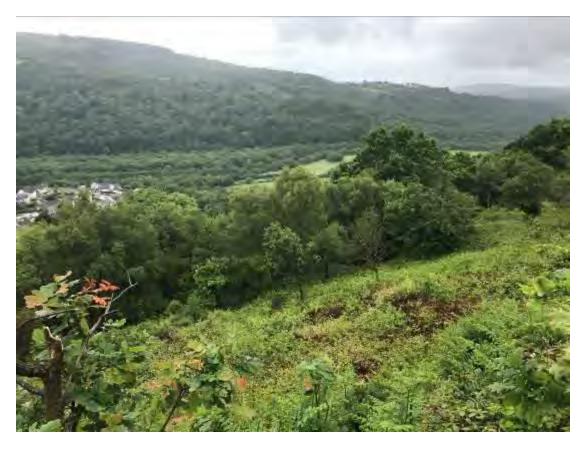
The inspection route then accessed the area encompassed by Site 2, crossing a derelict fence-line and heading east across an area of dense fern and bramble vegetation with a sporadic cover of trees. The density of vegetation prevented close inspection of materials or topography and access was extremely difficult (photographs 22, 24 and 25).

Photograph 22 – General view of Site 2 showing dense vegetation coverage

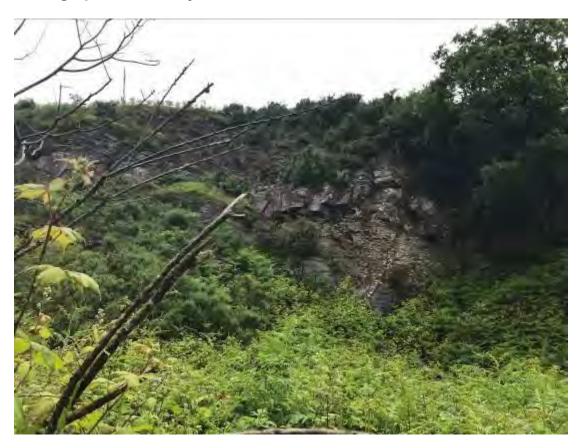
At the northern boundary of the site, the overgrown remains of a former access track, presumably leading to the un-named quarry, appeared to be present (photograph 23).

Photograph 23 – Quarry face above Site 2

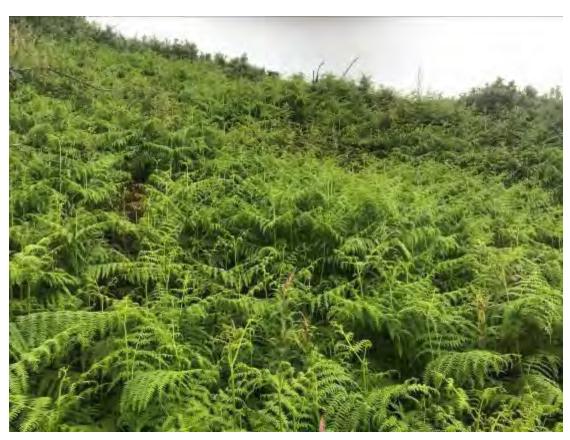
Photograph 24 – Mid point of Site 2 showing dense undergrowth

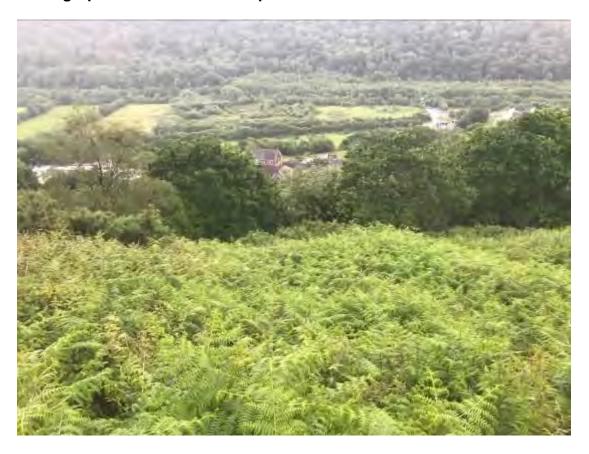
Photograph 25 – View down-slope from crest of Site 2

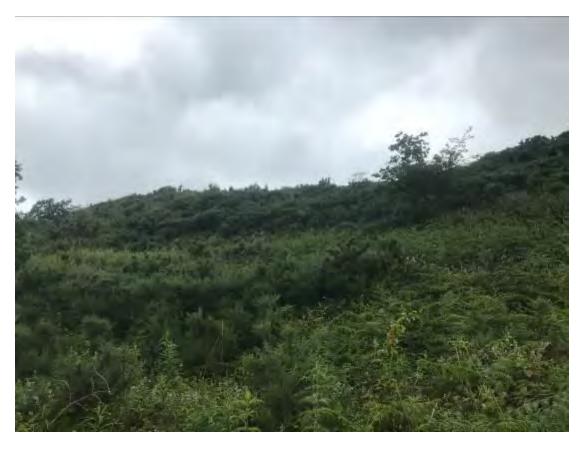
The inspection route then turned north east and viewed the series of recorded mine adits above Site 3, the entrances to which appeared to have collapsed many years ago. The colliery tips associated with these mine entries comprised a liner low mound of spoil forming a ridgeline at the head of Site 3 (photographs 26 to 28).

Photograph 26 – View of Site 3 from toe

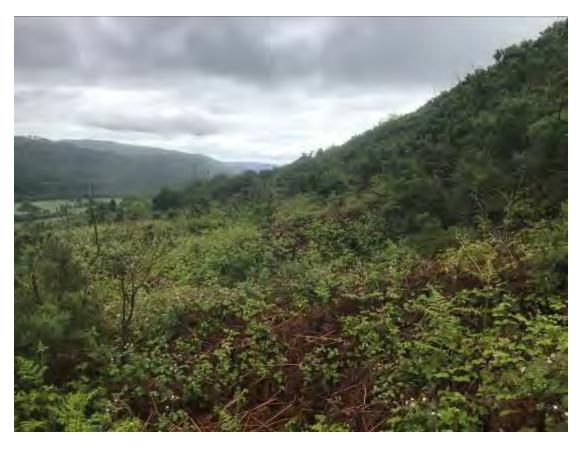
Photograph 28 – View of Site 3 showing collapsed adit positions

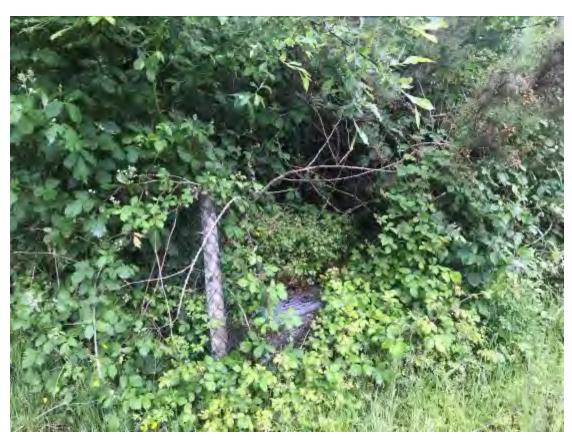
The watercourse disappeared and reappeared at several locations, probably through the coarse quarry spoil present, appearing again as a spring type feature at NGR 275067E 206915N (photograph 29). The watercourse then flowed in an unlined channel to enter a screened chamber at NGR 275135E 206891N (photograph 30), before entering a final chamber to the rear of Godre'r Graig Primary School at NGR 275157E 206892N (photograph 36). The watercourse then appeared to be culverted beneath the school.

Photograph 30 – Inlet chamber to rear of school

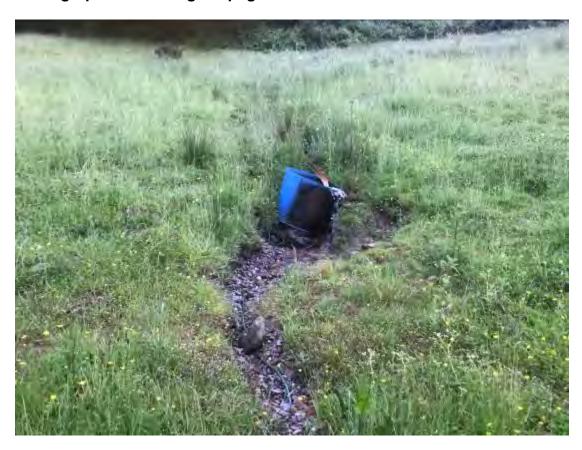
The inspection route traversed the slope behind Godre'r Graig Primary School, viewing the route of the watercourse referenced above and the drainage chambers to the rear of the school. A stone filled cut off drain with several manhole chambers was observed in the grazing field to the rear of the school, along with a spring located at approximate NGR 275164E 206992N. Flows from the spring were captured by the stone cut off drain (photographs 33, 35 and 37).

Photograph 35 – Strong seepage to rear of school

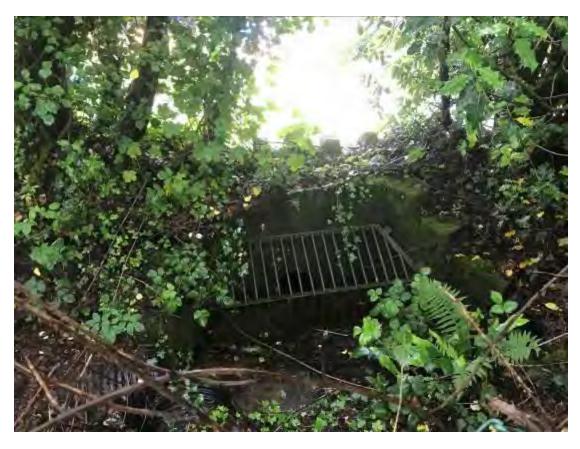
Photograph 36 – Inlet chamber at rear of school

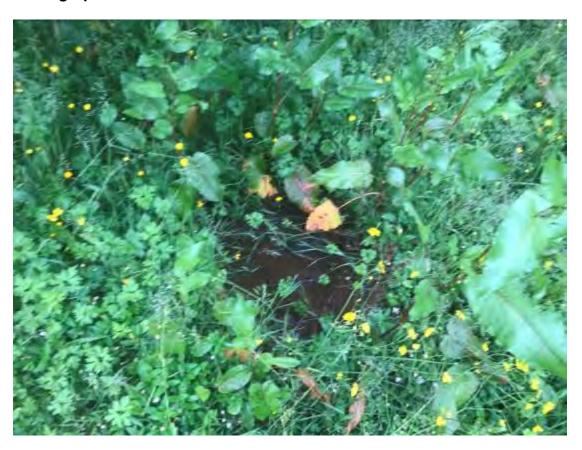
Photograph 37 – Manhole cover on line of stone filed cut off drain
