Godre'r Graig Primary School, Godre'r Graig Tip Remediation Assessment

Report Reference: ESP.7234e.04.3564

Godre'r Graig Primary School Tip Remediation Assessment

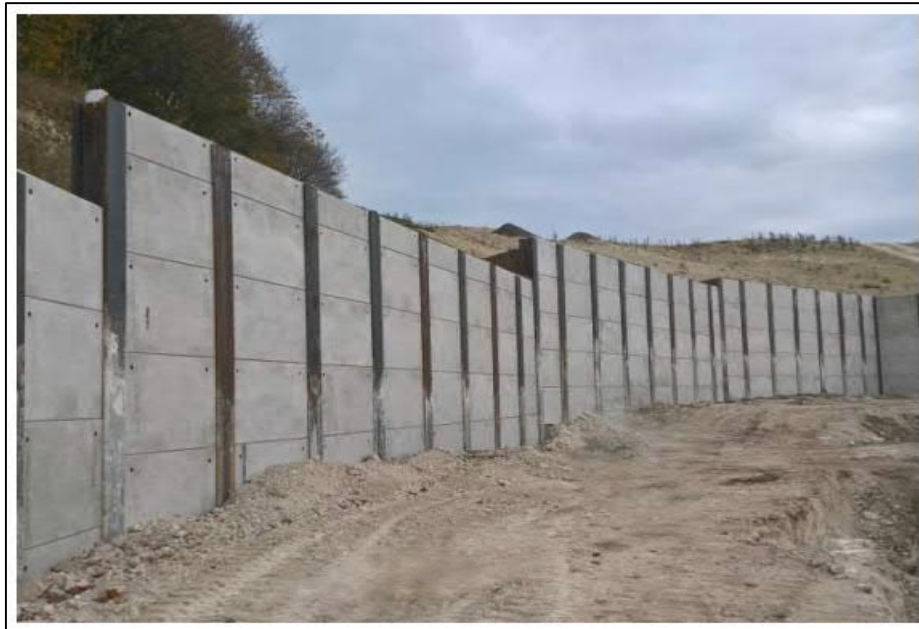
Embedded retaining walls will pass through the quarry spoil (if located on the tip) and penetrate the underlying competent strata and would be designed such that it is not reliant on the quarry spoil. Embedded retaining walls may be designed as a continuous line of bored piled or as a 'King Post' wall using steel columns spaced at centres commonly between 1m and 3m with the space between infilled with precast concrete panels. It has therefore been concluded that the embedded retaining wall option is the most viable option for the retaining structure solution and with the need for the structure to project above the existing ground surface to catch any potential landslip overtopping the structure and reaching the school, a King Post wall is considered the preferred solution.

Insert 3: King Post Retaining wall example

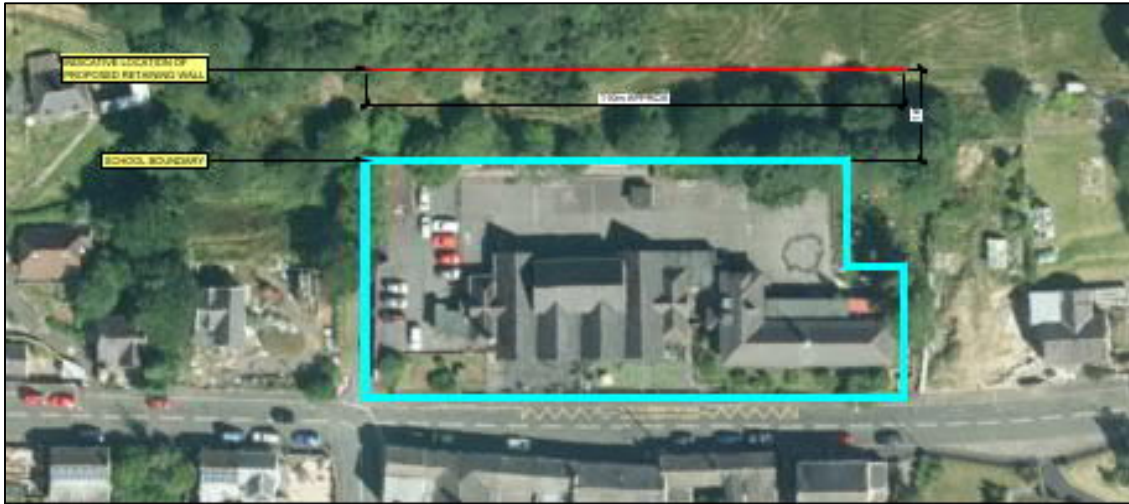
The main disadvantage of this type of wall is the limited site access, however this will be common to all solutions. The location of the proposed wall is shown in red on the insert below, and measures some 110m in length.

Insert 4: Possible location of wall

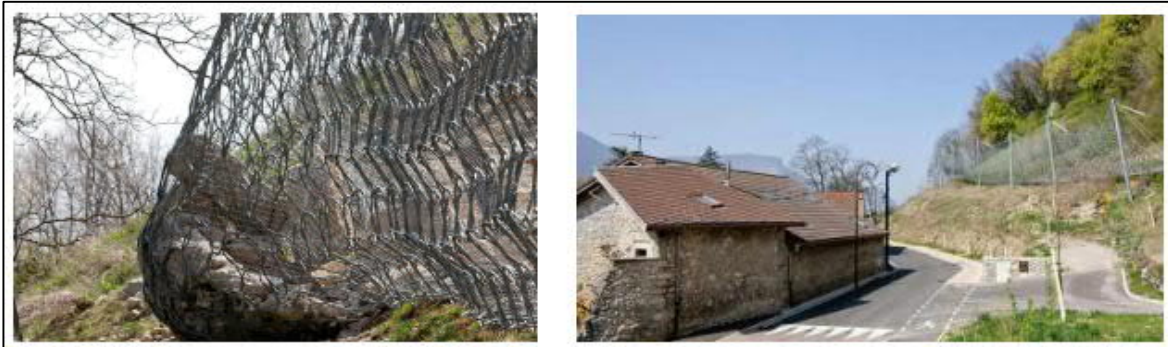
Rock netting has been considered as an infill between the king posts as an alternative to precast concrete panels as they will have less of a visual impact and will reduce the construction period. However, at this stage, this option has been discounted for two reasons. Firstly, there is a concern that in the event of a landslide occurring after a prolonged period of rainfall then the quarry spoil may act as a slurry so netting will be less effective. Secondly, rock netting is generally suited for local loads such as rocks and boulders travelling at high speed and not a larger landslide failure. Examples of rock netting are provided below:

Insert 5: Rock Netting examples

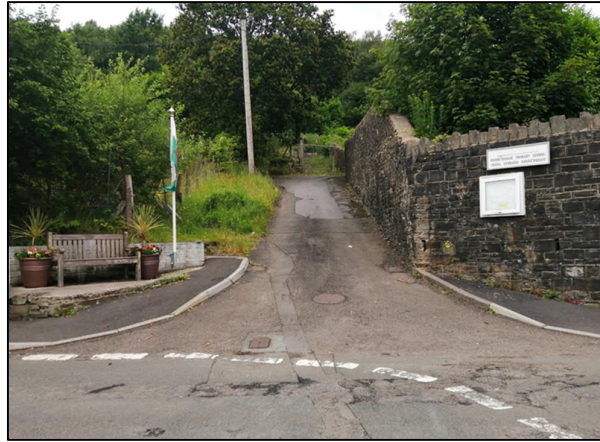
It is considered that the existing primary school could be used as the site compound for site welfare and material storage. The existing access road could be widened to form the main access to the site, see insert 7 below.

Insert 7: Existing School Entrance to be widened.

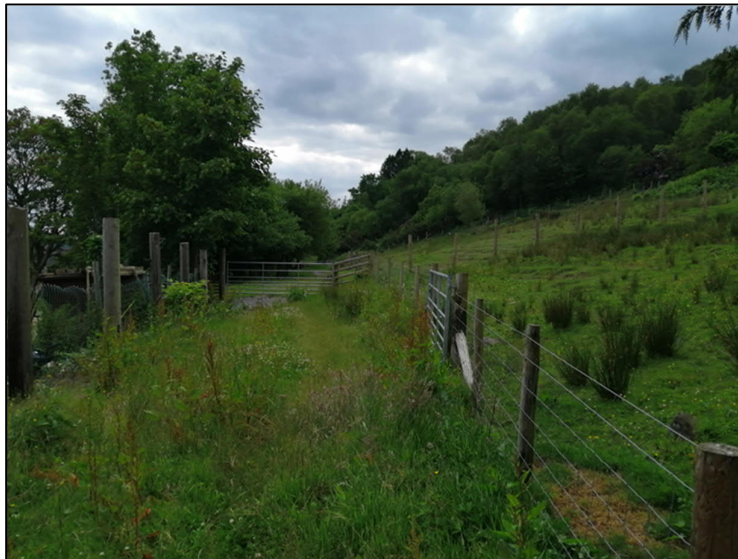
The improved and widened access road would also provide access to the work area for operatives and large plant (such as a piling rig and craneage). The location near the proposed retaining wall would need to be cleared of topsoil, vegetation and levelled for works to commence. A suitable working platform would need to be constructed prior to piling and lifting activities (in the area shown in the photograph below). Following piling, the wall would then be installed utilising a crane, after installation the site would be demobilised and the car park returned to normal operation. It is proposed (if acceptable), that the widened road (school access) would be left as a permanent install.

Insert 8: Existing School Entrance to be widened.
